SAFETY ALERT - ACCIDENT

Compressor Towed Forward onto Leg

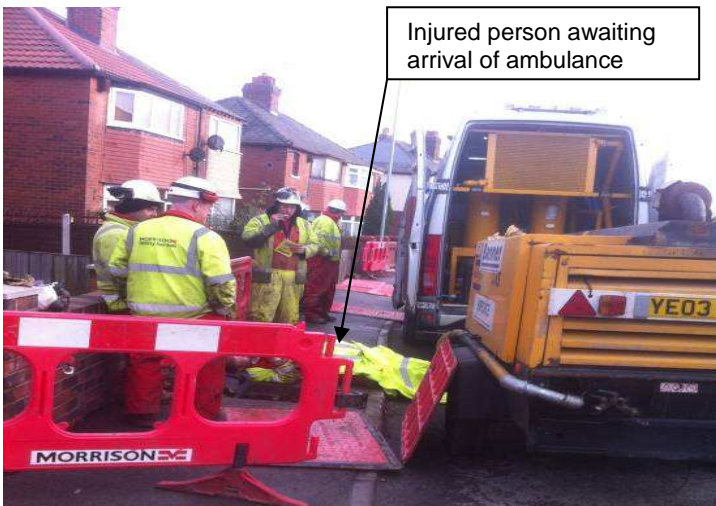
MUS and Whirlwind Utilities Ltd were carrying out lead pipe service replacement and lining. An MUS operative had lain on a footpath board on the ground to replace a ferrule in an excavation positioned between the lining compressor and van. As the Whirlwind operative was moving the van forward to the next excavation, he rolled the wheel of the compressor onto the leg of the MUS operative. On realising what was happening he immediately reversed and an ambulance was called to site. MUS operative had sustained a crush injury to his left leg, he was assessed at the hospital and released the same day.

- Any manoeuvres, forward or reversing, on site to reposition plant should be carried out with the aid of a banksman.
- When working on site ensure you are completely within the barriered area.
- When working in close proximity to others (MUS or subcontractors) you should ensure there is effective communication between all parties.
