Progressive Collapse of Structure at Mogden STW

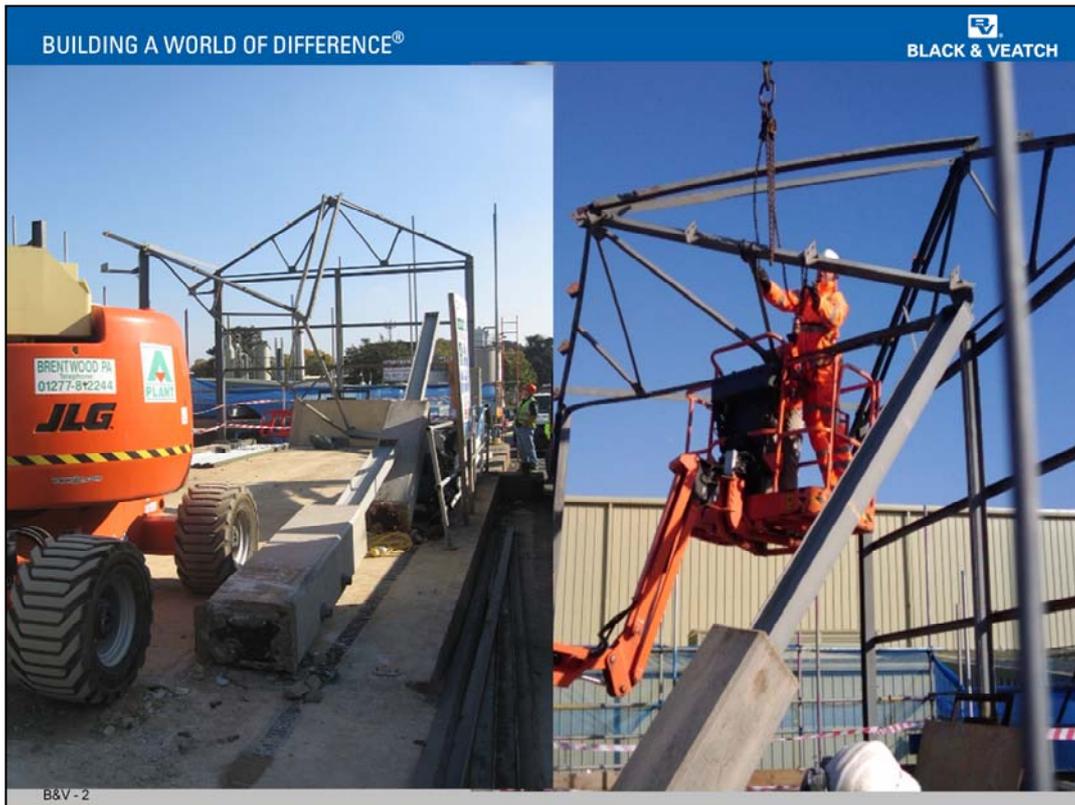
On the day of the incident the cladding and walls had already been removed. Steel was being stockpiled at one end of the slab, to be loaded later onto the lorry. The original plan was to load the steel directly onto the lorry, but the trusses were too big and a larger vehicle would be required

Trusses 6-4 had been removed

The truss along line 3 had been disconnected and was being lowered to the ground, as it did the truss caught on column B6 causing it to fall.

B6 fell onto the adjacent column which in turn fell onto the next column...in total 5 columns fell

Column B2, still connected to its truss, fell resulting in the truss landing on the basket of the MEWP, the persons in the basket sustained no injuries

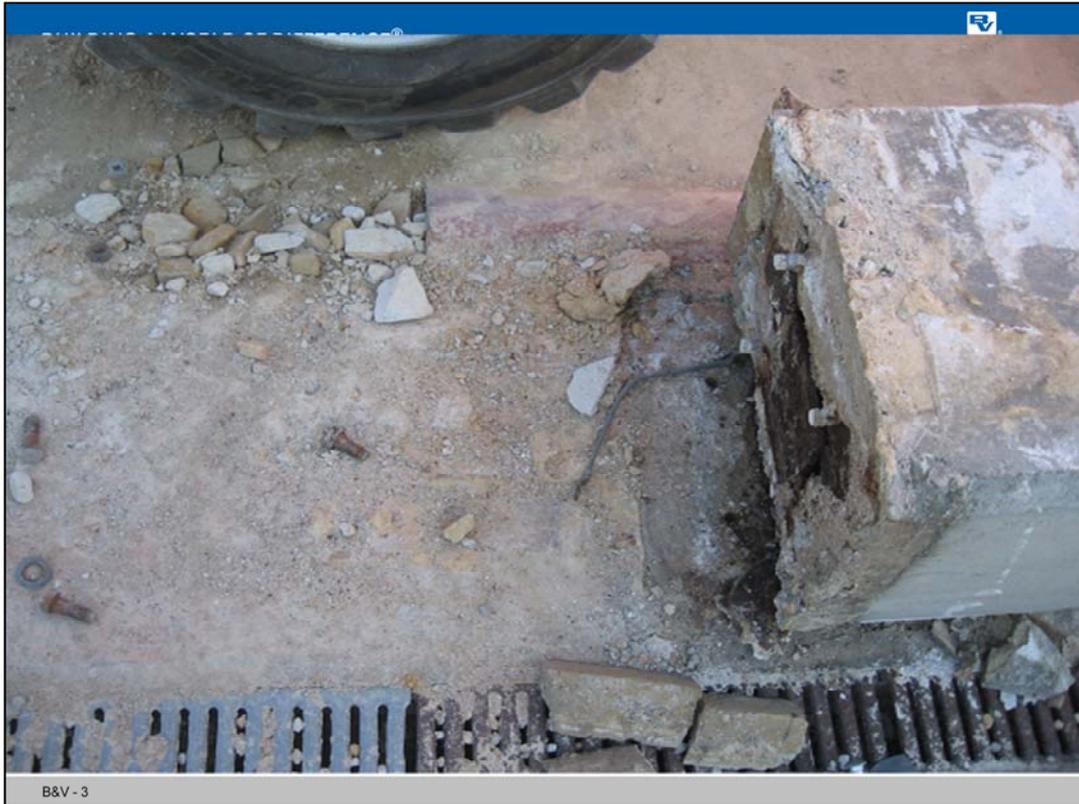
Inspection revealed the columns that fell were insufficiently connected to the slab. Projection of the anchors varied between 20mm to 40mm below the underside of the steel packing, below the base plate

- the structure would be stable as it was dismantled
 - Where connection details are covered and this cannot be validated then we must not assume it will be stable. So no unsupported members (e.g. columns or walls) permitted during dismantling operations
