Safety Alert

July 2011

Importance of Plant Reception Inspections

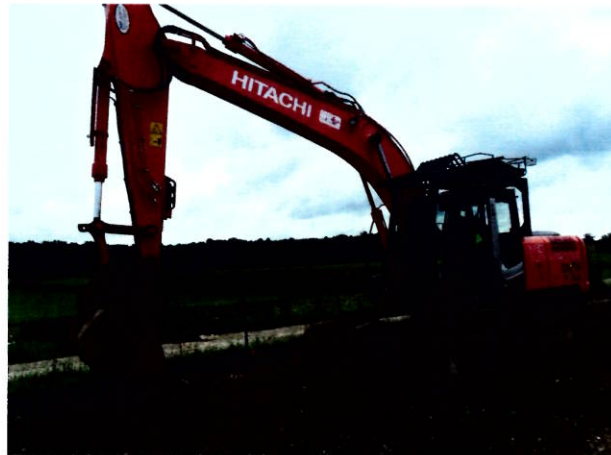
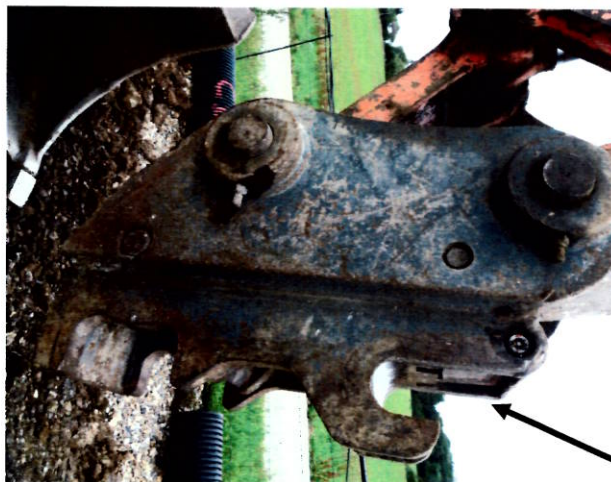
On arrival the machine was inspected by the section one plant inspector Guy Starley, on completing the reception inspection Guy found that only one lock was operating and that also the alarm in the cab was not working.

The Quick Hitch in question was a Hill twin locking hitch; this is the third incident with a Hill Quick Hitch with the same problem

This lock failed to close

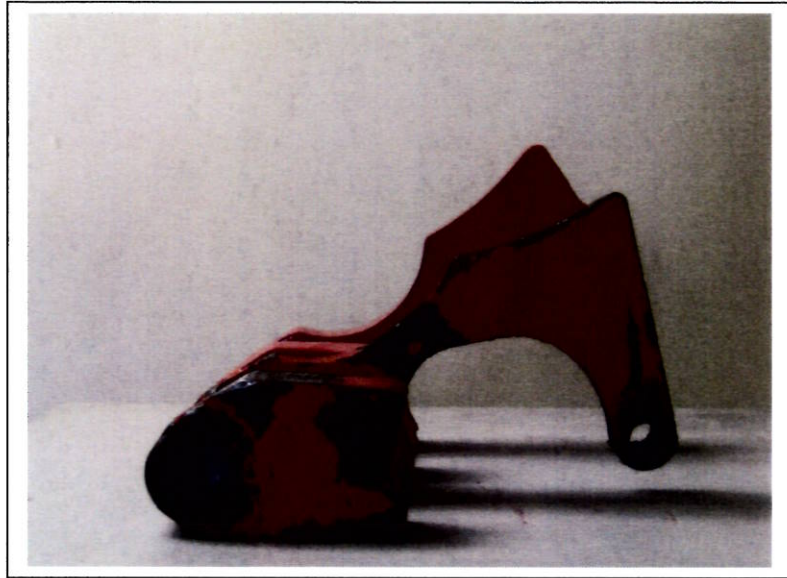
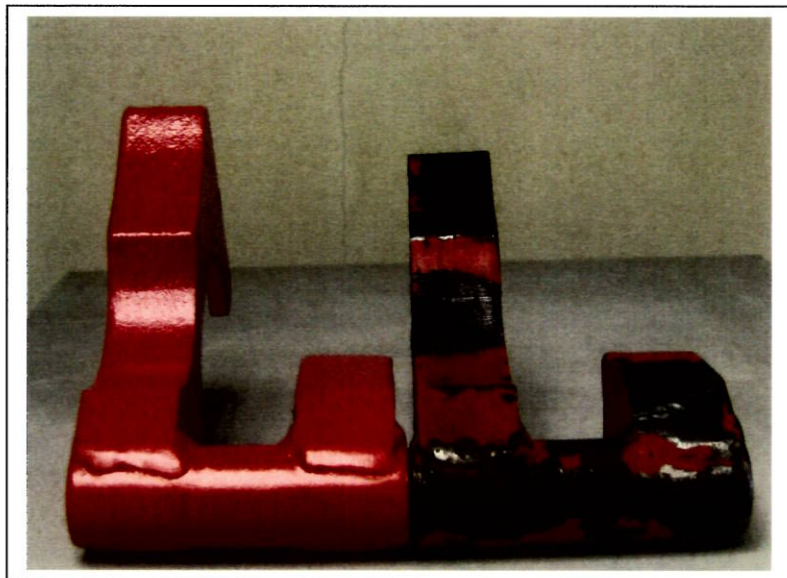
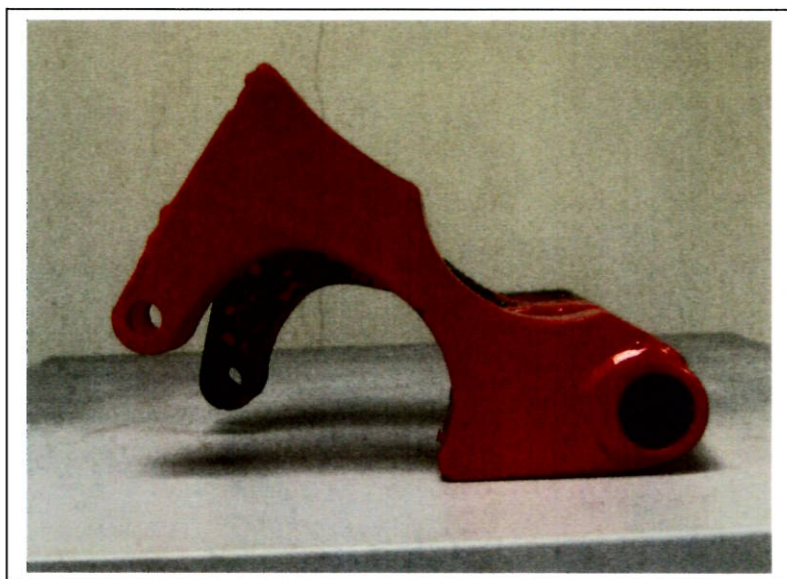
Hill Hitch Failure

The damage is being caused by operators trying to force the front pin of the buckets in past the closed front jaw.

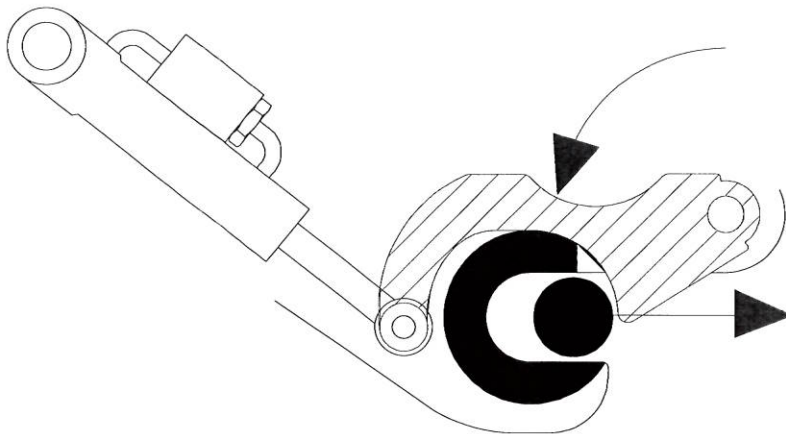
FRONT PIN TRYING TO FORCE ITS WAY OUT

Should the front pin try to force its way out from the front aperture the force is taken directly on top of the gub of the coupler (the large circular part that restrains the front pin). This cannot bend the safety lock in the way that has been seen in both cases of damage. The action of the front pin trying to force its way out would bend the mechanism in the opposite direction to the direction both safety mechanisms were actually bent. However the forces seen in this direction and the design of the safety mechanism means that it is virtually impossible for damage to occur in this event.

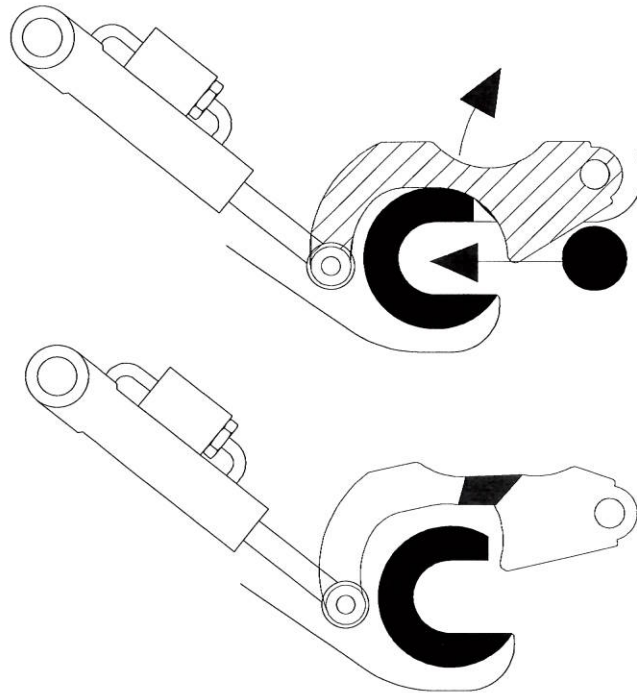
ABOVE SHOWS WHAT HAPPENS WHEN THE OPERATOR TRIES TO FORCE THE FRONT PIN OF THE ATTACHMENT PAST A CLOSED SAFETY LOCK. THIS WILL EVENTUALLY RESULT IN A BENT SAFETY LOCK WITH DAMAGE IN THE RED AREA IN THE LOWER DIAGRAM. THIS CAN OCCUR THROUGH THE INCORRECT USE OF THE COUPLER OR FAILURE TO LIFT AND CROWD THE ATTACHMENT BEFORE LOCKING THE COUPLER.

If the photos of the damaged safety mechanism are compared with the lower diagram above it can be clearly seen that this is the damage evident on these parts. The safety mechanism is designed to withstand forces far greater than any that could be seen if the front pin tries to escape from the front aperture. However if the operator tries to force the front pin in past the closed safety mechanism damage will occur as illustrated above. This is down to correct operator training and procedures.

With any make of coupler the attachment **MUST** be fully crowded before turning off the switch to lock the coupler. Failure to do this can also result in the rear hook missing the rear attachment pin.
