Significant Near Miss – 3T Excavator nearly overturned

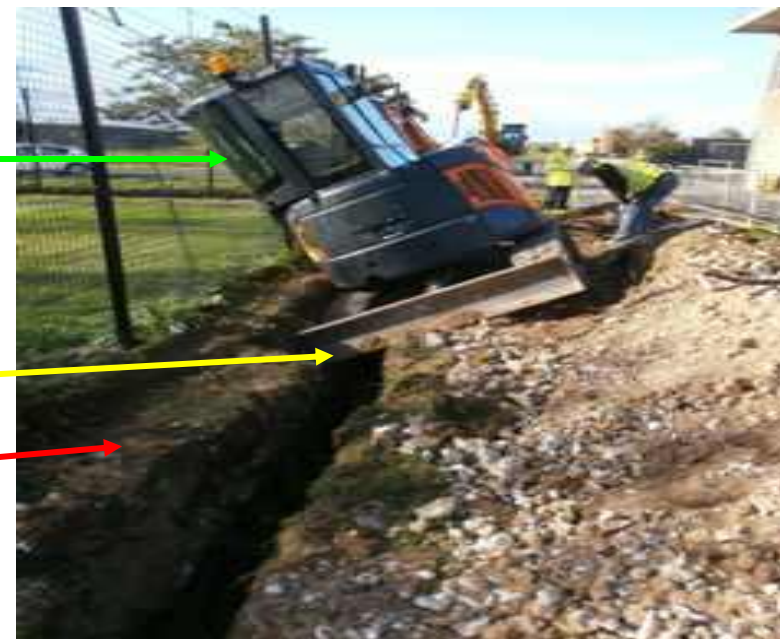
<p>Excavator indicated by yellow, excavator was working back from blue circle.</p>

- The excavator was straddling the service trench that had previously been dug. The excavator had to slew its tracks slightly to avoid coming into contact with one of the fence posts and in doing so got too close to the trench edge causing the inside tracks (and trench edge) to slip into the excavation. As the trench was only 300mm wide the machine did not overturn but leaned over until the underside of the excavator came to rest on the ground.

- There was a change in the methodology of the works but the RAMS was not reviewed prior to continuing with the work. The excavator operator did not inform management.
- The excavator should not have straddled the excavation. Track loading should be away from trench.
- Trench should have been positioned further away from fence to allow adequate working room.
- The Banksman should have informed the excavator operator he was too close to the edge of the excavation.
- Banksman in attendance did not have formal training.
- Experienced ground worker in attendance did not have formal "Excavator Banksman" training.

- All Special Projects PM's to issue instruction to their site teams that excavators are not to straddle trenches unless temporary works design is in place for the activity.
- Special Projects PM's to review safety planning on current sites with particular emphasis on detail of method statements in relation to site/programme constraints and changes.
- All Special Projects Partners to review their behavioural awareness campaign progress.
- All Special Projects site teams to complete a TBT on what went wrong, and what could have gone wrong (Injury to operator and plant)
- All Special Projects sites to update site induction and site rules, with the NO straddling rule.
- Competence of operatives to be detailed in RAMS.
