## Sheared Bolts Discovered on JLG Aerial Lift Boom Connections to Platform after Physical Inspection

**Lesson ID:** 2012-BNL-Aerial-0001

**Originator:** Brookhaven National Laboratory

**Date:** July 30, 2012

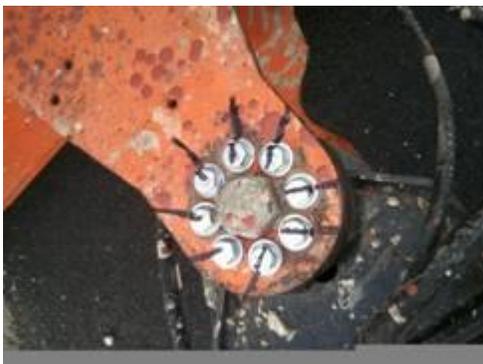
Eight bolts as they should be surrounding the main man lift bucket attachment bolt.

Note the orientation of this attachment point of the bucket to the boom is horizontal.

- Temporarily take all aerial lifts JLG model 860SJ out of service until they can be inspected.
- Physically inspect the eight (8) 3/8-inch platform-rotator attachment bolts that surround the main center pin that holds the basket to the boom. If necessary raise the environmental protective cover.
- Visual inspections are not sufficient because the bolts are oriented vertically and appear intact.
- Follow the manufacturer's guidance for inspections but it is recommended to examine the bolts prior to each use particularly if the basket struck an object or was subjected to an external lateral force.

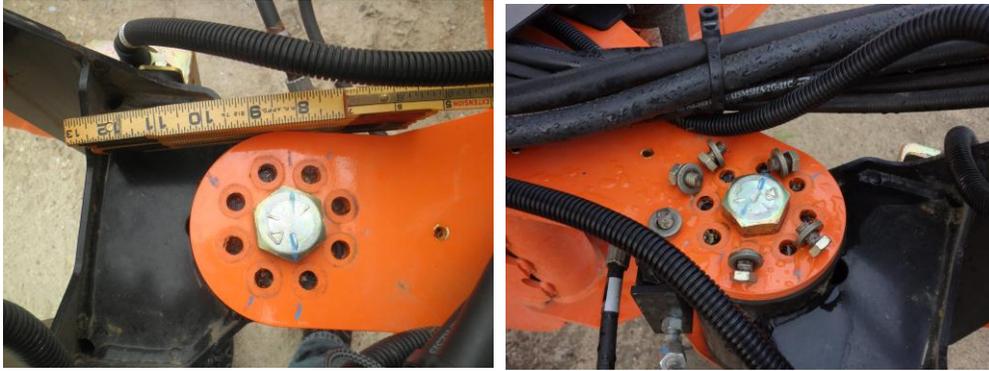
**Statement:** A JLG model 860SJ aerial lift was found to have all eight of its platform rotator attachment bolts sheared in half. This condition is not obvious during a visual inspection. Although there was no risk of the platform detaching from the boom the horizontal rotation capacity of the platform was severely compromised.

Initial inspection of the failed bolts noted that corrosion had formed on the failed surface of six (6) bolts indicating that these failures occurred sometime in the past.

The lift manufacturer has stated that these bolts can fail if they experience excessive force or contact between the platform and another object or structure and should be checked as part of manufacturer's recommended inspections.

Remains of the eight sheared bolts after the tops were lifted out of the holes.

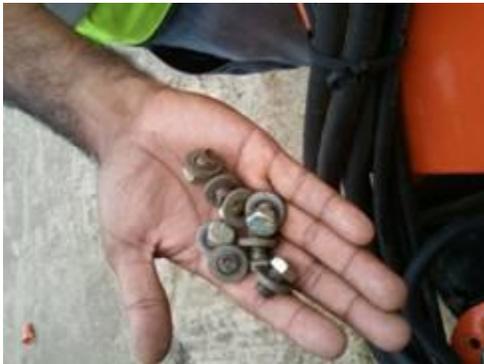
Tops of the sheared bolts.
