## Porta-Davit Failure

OHS/SNF/73

## Incident Details

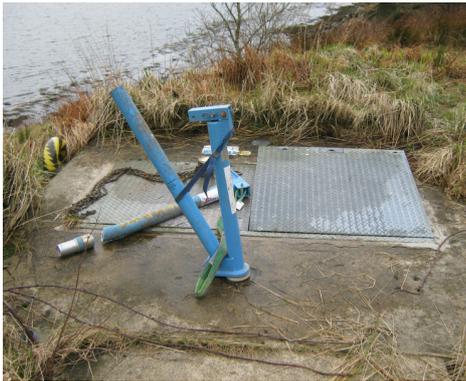
Davit position and chamber covers

- The position of the davit socket used during the task is located too close to the open cover, restricting the amount of clearance that was required to ensure a safe lift.

- The davit socket was measured as being only 650mm from its centre to the top of the lifting point. This meant that the davit was being used outside of the manufacturers recommended operational design parameters of between 800mm – 1200mm radius

- The position of the davit socket has resulted in the pump being lifted at an angle, instead of the required vertical lift
- There was another davit point available which was installed during the construction of the site; however this was not used as the operatives raised safety concerns in relation to its position at the handover stage.

- Those carrying out mechanical lifting tasks must ensure adequate clearance is available within the designated lifting zone to facilitate an unobstructed lift.

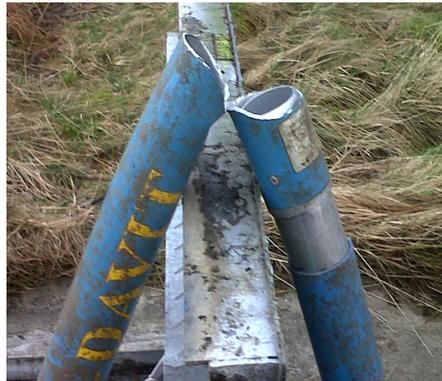
Failed Davit Arm

- As a result of the pump becoming jammed the operative applied additional force in an attempt to free it. This force combined with the total weight of the pump and chain block brought the davit arm onto the edge of the cover creating a pressure point on the side of the davit arm

In conclusion, this incident happened due to the combination of a poorly positioned davit socket located directly behind the open cover and the angle of the lift which prevented the free movement of the pump during the lift. These factors combined with the weight of the pump, chain block and amount of force applied by the operative as the pump jammed, meant that the davit arm was pulled forward onto the raised cover putting the davit arm under a force it was not designed for, causing it to buckle and fail.

- All lifting equipment being used has been inspected by a competent person prior to use and it is within the recommended period of inspection.
- All lifting equipment is used within the manufactures required design parameters. Advice on these parameters can be obtained from the manufacturer or supplier of the equipment

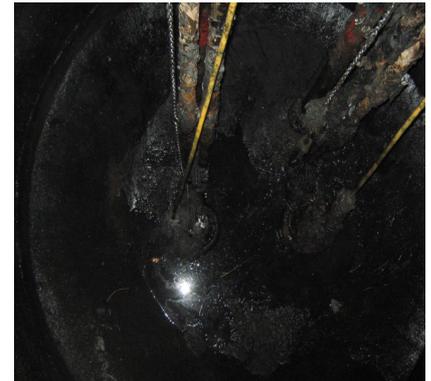
Wet Well guide rails

- The guide rails displayed signs of corrosion and a build up of and waste materials. This could have also contributed to the pump becoming jammed during the lift
