TITLE: Isolation Procedures

At 7am on the 05/07/2011 at Beckton STW the site team returned to site to find PST 7 partially filled with drainage water.

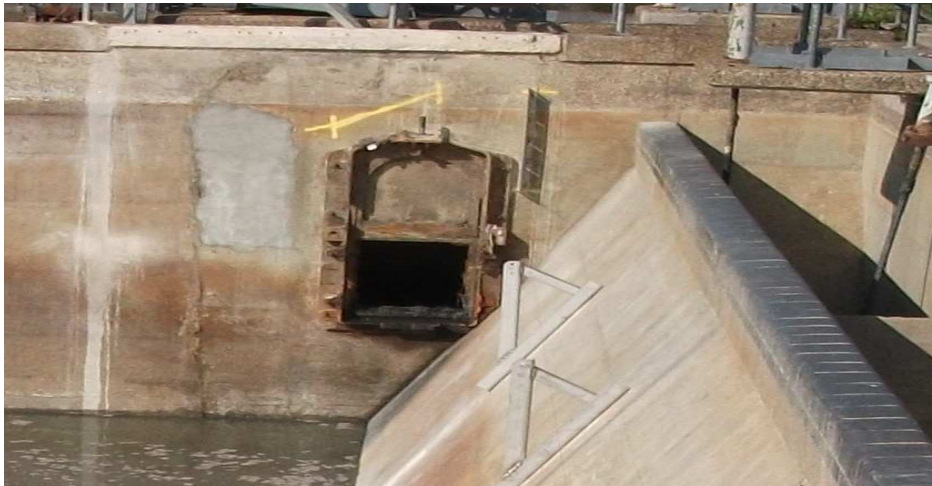
It was rapidly discovered that this ingress was a combination of two factors;

- A door from an existing penstock had been removed and no blanking plate installed
- One of Thames Water's Drainage pumps had failed over night.

A lack of understanding of the process and the required levels of isolation.

- Production of a clear isolation procedure.
- Specific risk assessment and method statements required which must include details of downstream processes that could possibly fail. This will explain the risks of operating and working existing isolations.
- Clear identification of isolated equipment and cross referenced on method statement
- Additional "Hold Points" to be included / requested in Method Statements, identifying the critical process interfaces and potential failures / scenarios.
- Change to method statement review form to include process interfaces.
- Process tool box talk with all site personnel before commencement of work
- Ensure Supervisors fully understand processes and key checks regarding isolation / blanking procedures.
