**Client and
Contractors Health
Safety and
Environmental
Updates**

August 2012

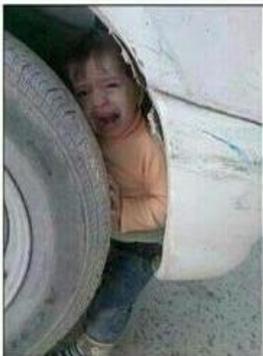
Recently a Utility Company reported details of a significant Near Miss, when a child was spotted hiding in the wheel arch of the vehicle.

The child was spotted as the driver undertook a full 360 safety check of the vehicle before setting off. The consequences if the driver had not done this could have been fatal.

A crew working for a utility company found this young child in the wheel well of their truck while conducting a "CIRCLE OF SAFETY" of the company truck the crew members were driving before moving the vehicle.

This incident highlights the importance for all drivers to do a 360 safety check of the vehicle before setting off.

Just another reason for us to do a vehicle CIRCLE OF SAFETY check before driving off in our vehicles
