## Environmental Alert

### Water main flooding 'near miss':

A recent flooding 'near miss' occurred during modifications required to a Developer main in advance of its connection to a new section of water undertaker's supply main.

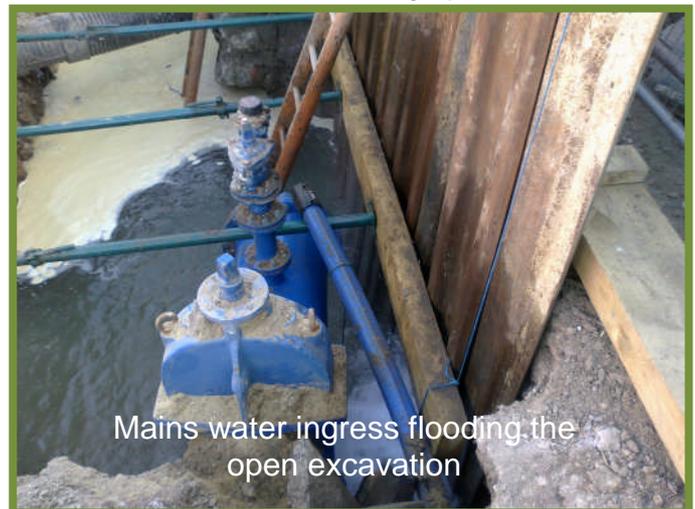
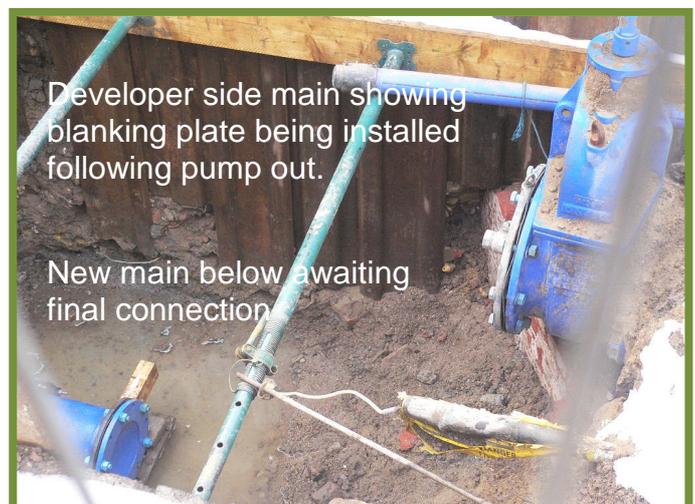
During this operation, pressurised water began leaking into the excavation from the part dismantled joint into the excavation, and an attempt to stem the flow from the site main was made by checking that the valve was fully closed. This initially failed until it was realised that the valve operation was non-standard (i.e. anti-clockwise closing). Only after the excavation had become flooded was the water flow and ingress finally stopped.

Examination of the hydrant following its removal showed that it had become frozen due to the ambient weather conditions (a number of days of sub-zero temperatures), exposure of the pipe end and hydrant within the open excavation, and lack of frost valve on the hydrant.

The excavation was in close proximity to a Network Rail tunnel structure which luckily was not directly affected by the floodwater, however the situation could have had much more serious consequences had the flow not been brought under control when it was. The floodwater was pumped to a nearby surface water drain.

- Ensure that comprehensive 'as-built' drawings and information are provided for 'private' mains and infrastructure; these should be available from the developer as part of the 'Health and Safety File' (particularly for mains installed under the CDM regs), or as part of the client (i.e. water undertaker) 'pre-construction information'.

- Be mindful of the prevailing weather conditions! Water mains are installed at depth to prevent or minimise the risk of freezing. If exposed by removal of soil, and left un-insulated they may quickly become frozen and fracture, or (as in this case) create a false impression of being dry or de-pressurised.

- As part of contingency planning, always check valve operation before dismantling pipework that may be 'in service'. If in doubt about its operation or function, ensure that thorough investigation is carried out to check markings and instructions on the infrastructure, or contact the developer / installer for advice and / or technical support.

- Ensure that a detailed contingency plan is in place that considers 'what could go wrong' and ensure that suitable equipment is available on stand-by to handle any emergency situation that may arise.

- Carefully check trench and excavation supports following flooding and subsequent pump out of an excavation to ensure that the supports are in good condition and ground stability has not been compromised (i.e. they are not at risk of collapse).
