Safety Alert (Not VMR)

What Happened?

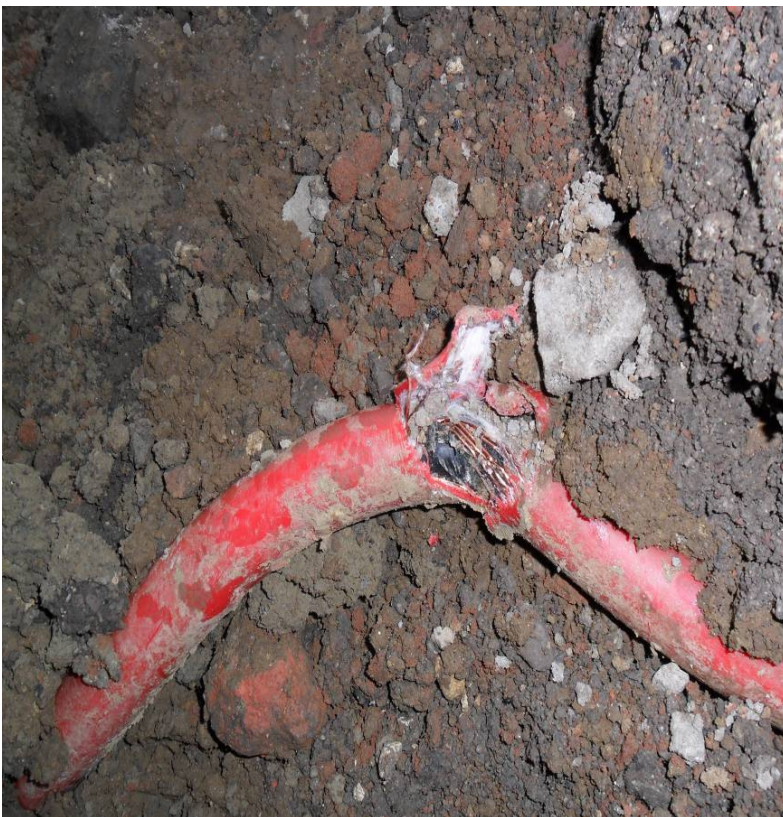
Whilst undertaking an excavation works an MUS team struck a HV cable while using a mini excavator causing damage to the outer sheath.

- The team did not thoroughly CAT scan the area to locate the HV cable
- The team did not carry out enough trial holes to accurately locate the HV cable
- The electric drawings were inaccurate, showing the HV cable in a different position
- There was no sand in and around the cable that would have helped identify its presence
- The incident was a routine violation as rules were available, understood and not followed
- Using mechanical tools within 0.5m of underground services.

- Never assume utility plans are accurate
- Dig as many trial holes as necessary to establish the exact position of underground services.
- Before excavation always use utility plans to help locate underground plant.
- Use CAT & Genny and trial holes to confirm the utility plans.
