Safety Alert Number 178 issue 31.01.2011

Overtuned Excavator

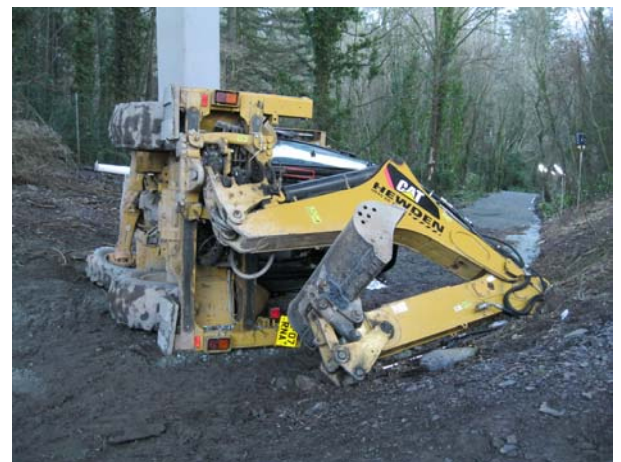
During enabling works a wheeled 180° excavator overturned. The machine was in the process of loading a dumper with stone to create a temporary access road. The route along which the excavator was approaching the stockpile involved traversing across a gradient.

As the operator raised the bucket in excess of 2m and manoeuvred, the machine slowly tipped, coming to rest on its side and backhoe.

- The excavator operator made an error of judgement and approached the stockpile across the gradient.
- The plant tyres were found to be under inflated.
- The work site gradients had not been adequately risk assessed prior to works commencing.
- The operator had a CPCS competency but not for this item of plant.

- Ensure tyres on plant are correctly inflated in line with manufactures recommendations.
- Check plant operators CPCS / NPORS competencies are correct for the plant being used.
- Ensure plant supplier's pre-delivery inspections (PDI) are complete on delivery of the plant, including tyres.
- Carefully risk assess works on gradients.
