PRODUCT ADVISORY	5337
-------------------------	-------------

MODEL(S): PS5000-PS6000 & TA5s-TA6s swivel skip dumpers
AFFECTED built between June 2004 and June 2010

SUBJECT: Skip cylinder pin inspection

DATE: 18th May 2012

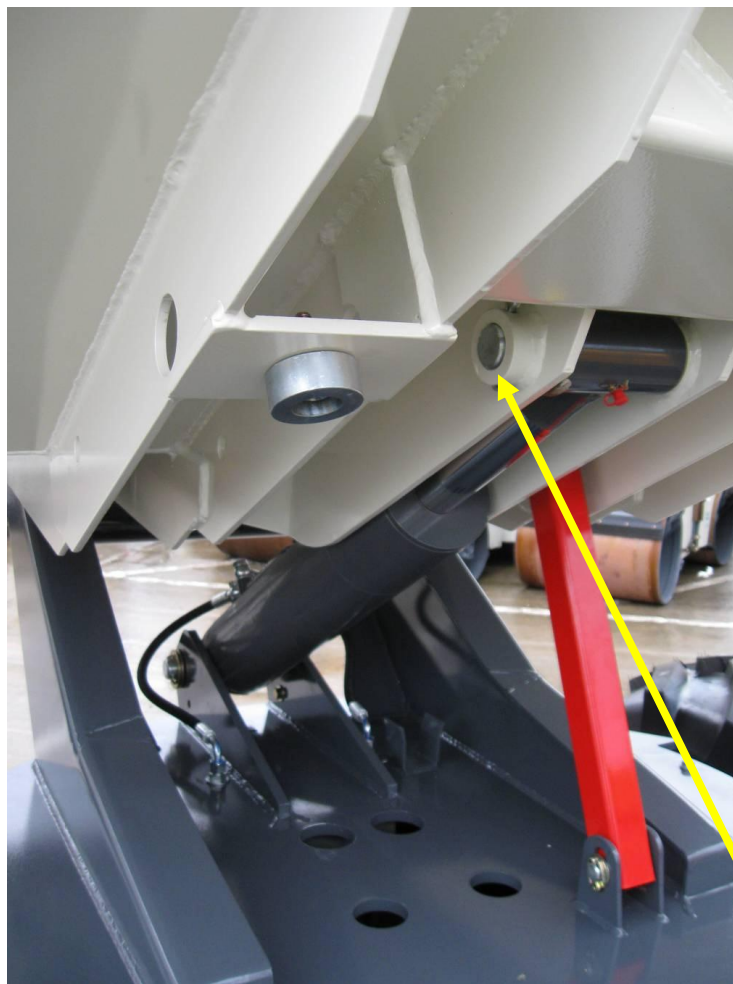
Picture 1

Pin to be inspected

It is important that the cylinder & skip bores are aligned before replacing the pin. There is a risk of displacing the bushes if excessive force is used to insert the pin. If there is any abnormal wear to the pin or the bushes have been displaced, then a new pin should be fitted and the bushes re-located.

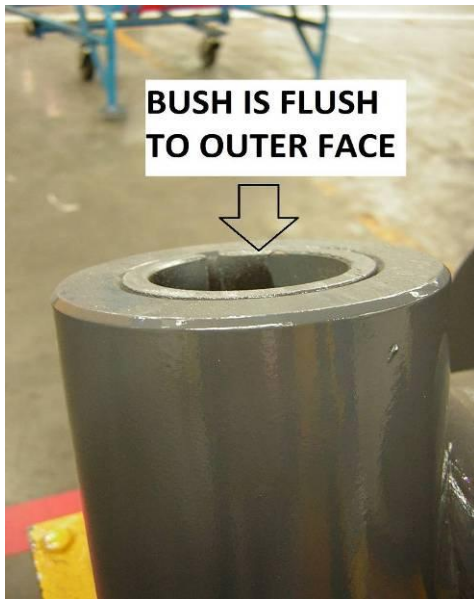
Picture 4

During the machines next routine inspection/service, inspect the top skip hydraulic cylinder pin. This must be checked for abnormal wear (see pictures 2 & 3). This will involve the removal the top skip cylinder pin (part number 1585-1439 - Picture 1) to check its condition. Whilst the pin is removed also check that the two bushes (part number 1583-1103) on each side of the rod end of the skip cylinder are in the correct position (picture 4).

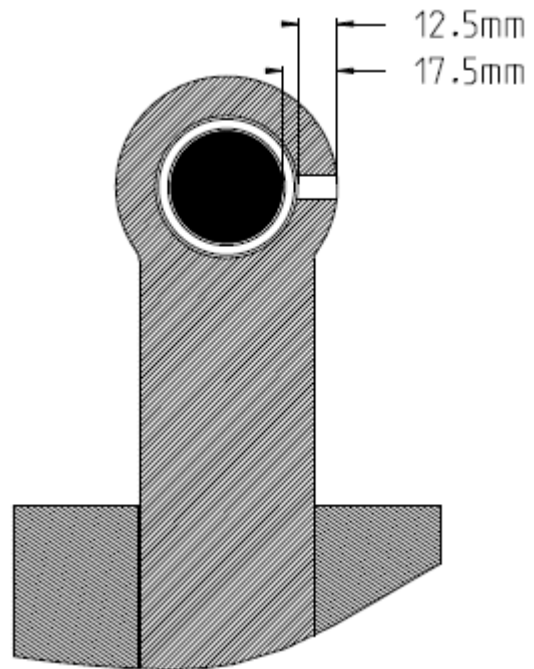
Picture 5

(picture number 5). The measurement recorded, if there has not been any displacement of the bush, should be 17.5mm. If the bush has been displaced then expect to find a reading of 12.5mm. If a lower reading is found then please remove the pin and check the bushes inside the cylinder rod end for displacement/free play.

After refitting the pin a check can be carried out to make sure there has not been any displacement of the bush. This can be done by removing the grease nipple and measuring the distance down the drilled grease orifice as per the attached diagram
