132kV Cable Damaged by an Excavator at Telford Road Grid Substation

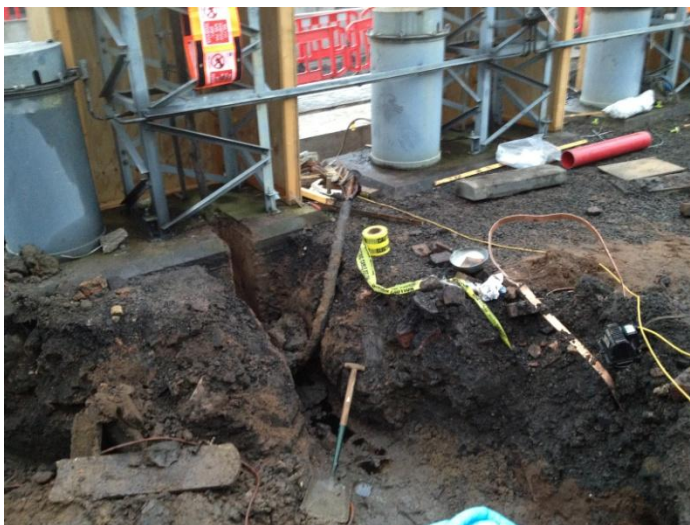
On the 8th November 2011 an excavator struck and damaged a 132kV cable in the substation compound – fortunately it was not in service. A contractor was installing ducts for a 33kV cable contingency circuit associated with a Grid Transformer replacement project. In addition to the significant repair costs this incident had the potential to lead to serious injury had the cable been in service.

The cause of the incident was the inadequate planning of the ongoing excavation and duct laying works and the subsequent decision to proceed with activities for which there was not an approved method of work.

Damaged 132kv Cable

- Always consider the full scope of works and plan effectively.
- Do not deviate from the method of work without prior agreement/review with your supervisor.
- Visual cable markers which are disturbed/removed must be reported immediately to your supervisor/site manager and works must stop immediately.
- The method statement for works should record any agreement with the SAP on specific limitations associated with the proposed method of work.

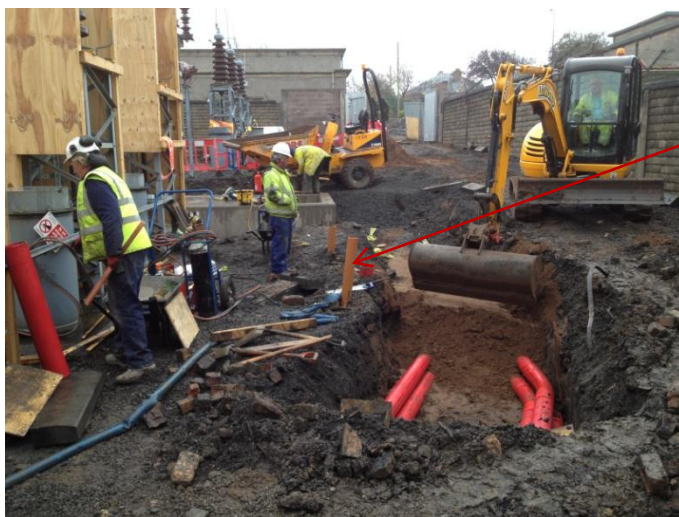
Visual cable marker
