Safety Alert

NEAR MISS Cable Drum Breakaway

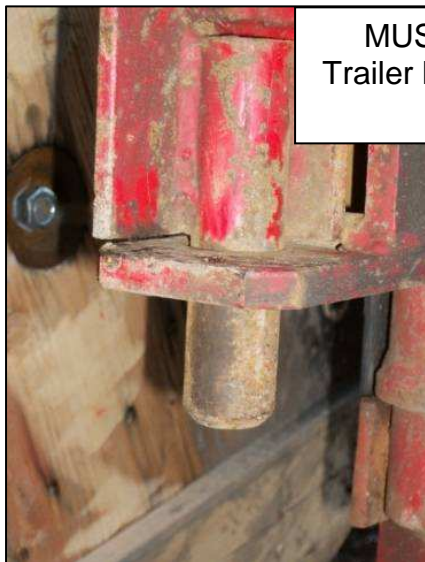
MUS Plant Cable
Trailer bar retaining lug

It was also found that the GAP trailer retaining bar had a shorter “retaining lug” than that on the Morrison plant cable trailer.

- Be trained and competent to use the plant/equipment.
- Ensure that all securing devices are correctly aligned and fitted.
- Visually and physically check that safety pins / clips are correctly fitted and secure.
- Report all defects and damages as a matter of urgency and do not use if not safe/serviceable.
- Always ensure that all towed loads are secured before driving off.

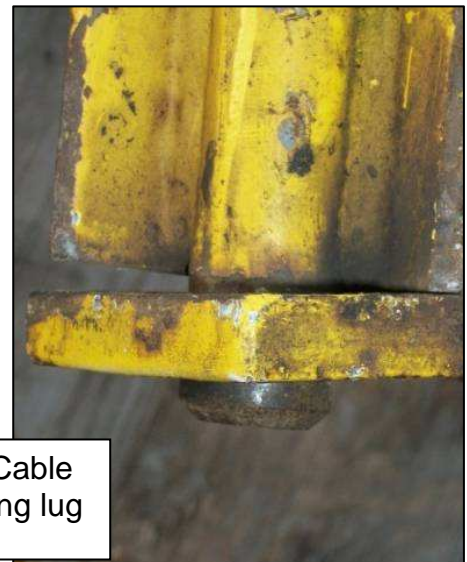
GAP Plant Hire Cable
Trailer bar retaining lug

Investigation identified human error in that the support driver had failed to carry out adequate checks to confirm the security of the load by correctly locating the retaining bar lug in its housing.
