11KV Cable strike damage by Directional Drill

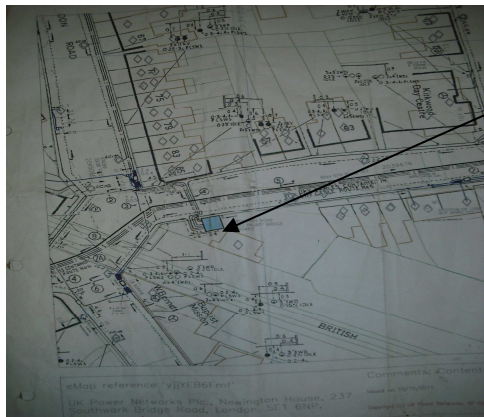
HV cable was clearly marked on the service drawing but team and management on site failed to check drawing.

Service drawing clearly depicting sub station and HV cables

This incident was briefed to all sub-contractors paying particular attention to each and every person whether sub contract or direct employee.

Select Surveys undertook a one-hour assessment per operative on underground service avoidance, including the use of CAT and GENNY. The strength of this one-to-one training is demonstrated by the underground service strike rate falling, with no further strikes occurring during November 2011.
