MEWP Incident - Metal Fatigue

Ref: SE 058

27th March 2012

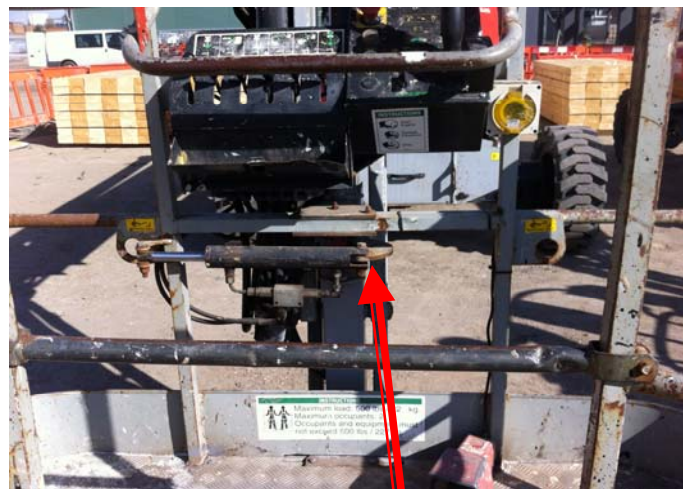
Further inspection found the mounting bracket to the horizontal ram had broken (see photos on next page).

Area of failure

- **Stop all use of the Nifty HR21 until further notice**
- **Inspect the joint at the horizontal ram on reception**
- **An investigation is being undertaken by the supply chain**

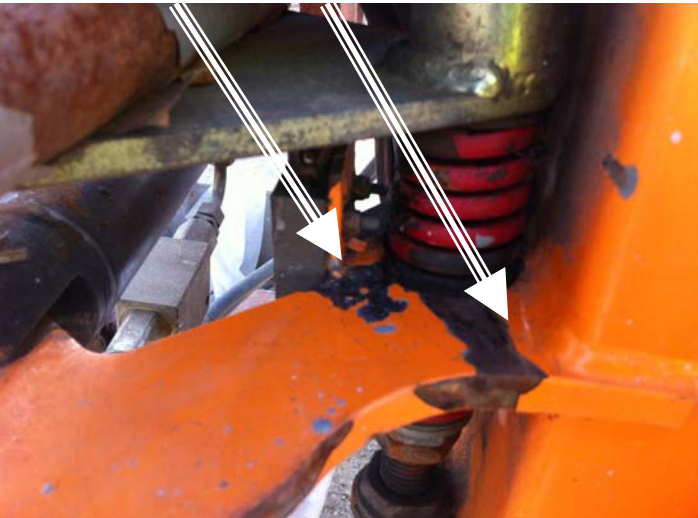
Area to be checked

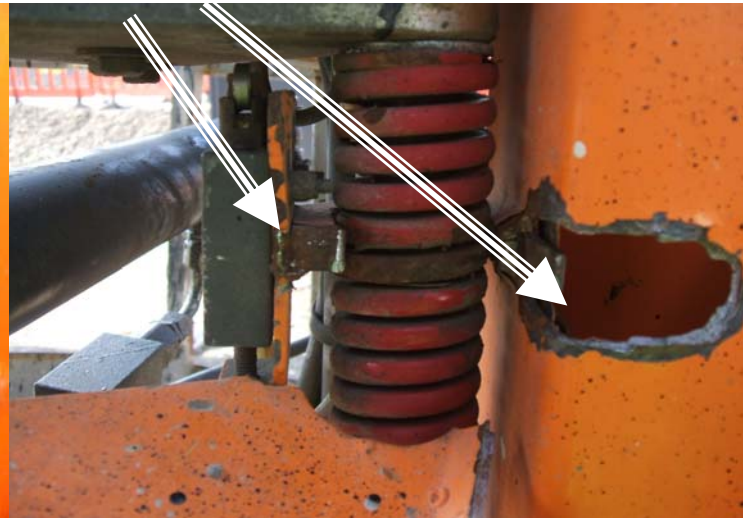
Metal fatigue on 1st MEWP

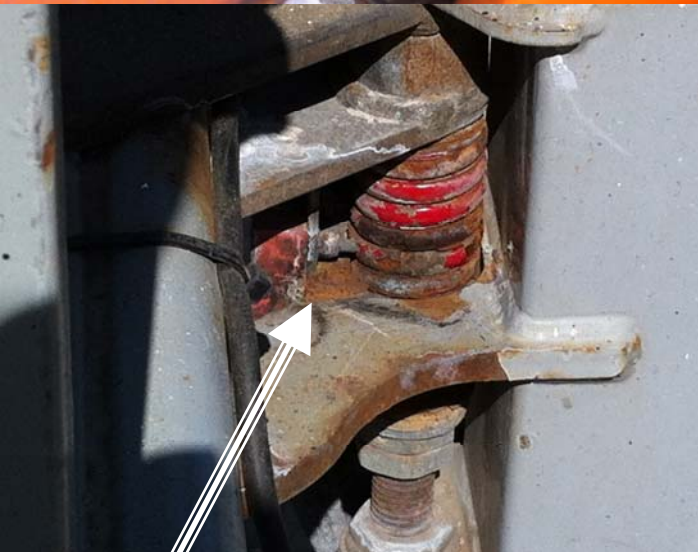
Re-weld on MEWP

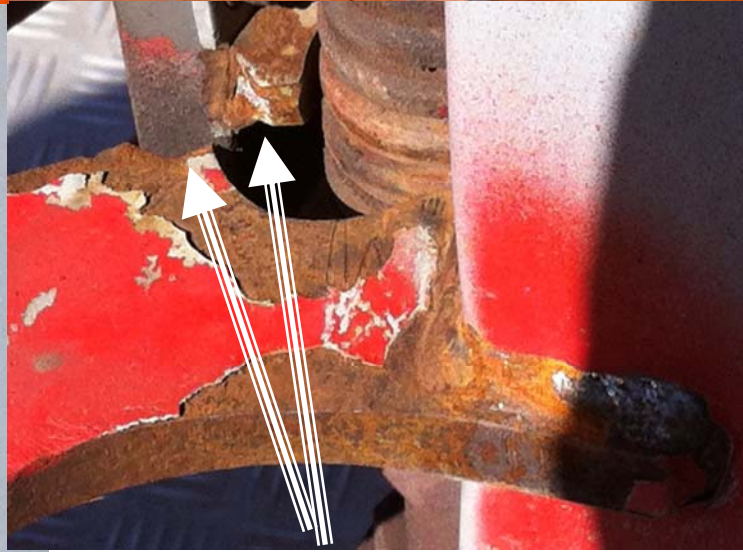
Joint not welded
