HEALTH AND SAFETY ALERT N°20

CRANE BOOMS CLASHING

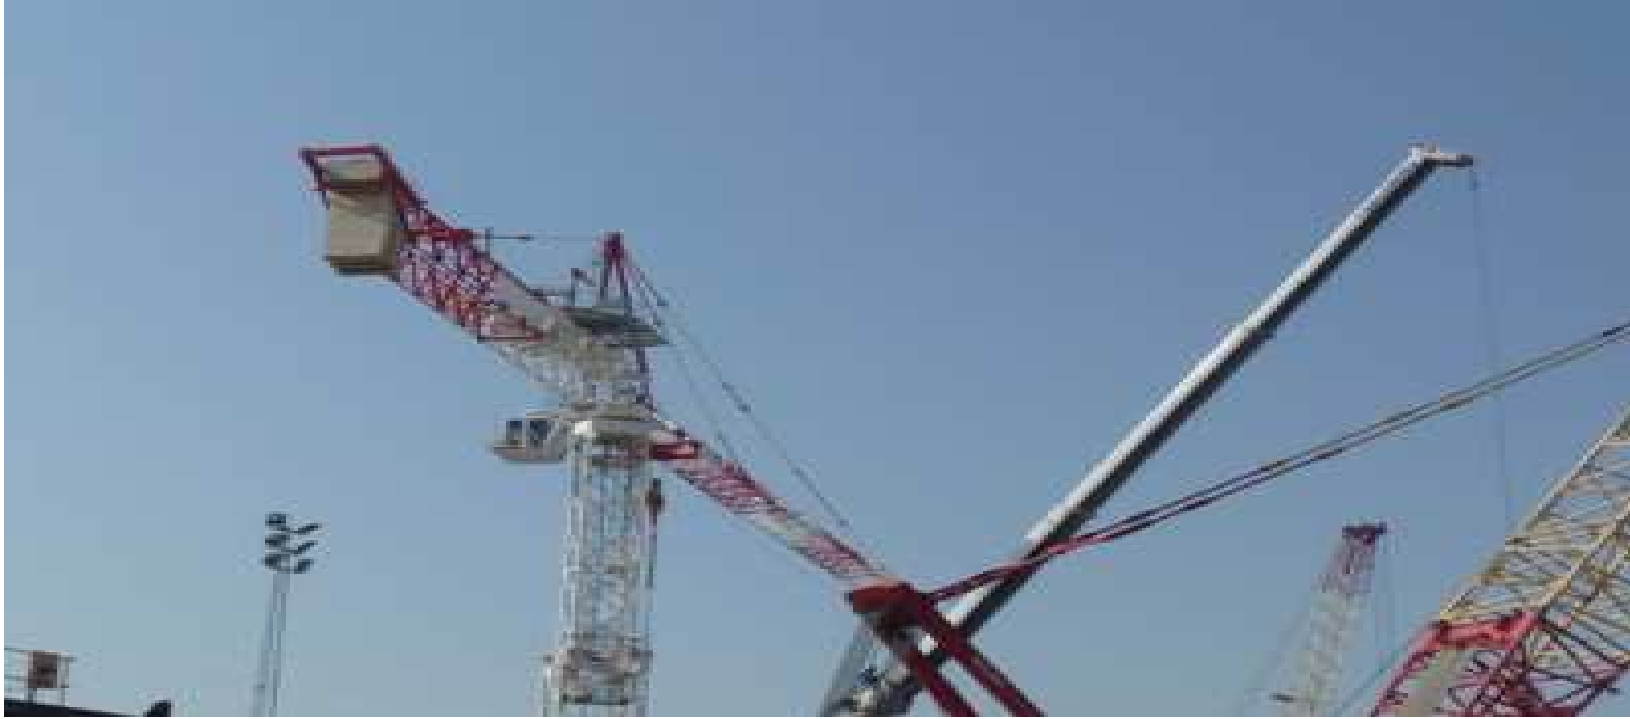
As the tower crane slewed into position, the rear boom, of the tower crane, came into contact with the mobile crane boom causing minor damage to mobile crane

The tower crane had a specific working zone in which to operate; the lift it was carrying out was outside of the agreed zone.

The boom of the mobile crane was extended so it could complete its task which meant the current configuration of the mobile crane had extended the boom an additional 20mtrs.

This change in the rigging configuration was not briefed to the banksman or crane operators at the start of their shift.

The banksman instructed the tower crane to slew to the PSC area thus causing the collision.

- Lack of change control management
- Lift supervisor did not brief the team on the addendum to the lift plan
- The tower crane banksman did not perceive a risk in carrying out the lift
- The tower crane lift, for the PSC area, was not planned or communicated
- The lift supervisor was not aware of the lift for PSC area
- Over the previous weekend the slew restriction device was switched off and not turned back on
