HEALTH AND SAFETY ALERT N^R15

STEALING OF EARTH CABLE AND COPPER FROM TRANSFORMER

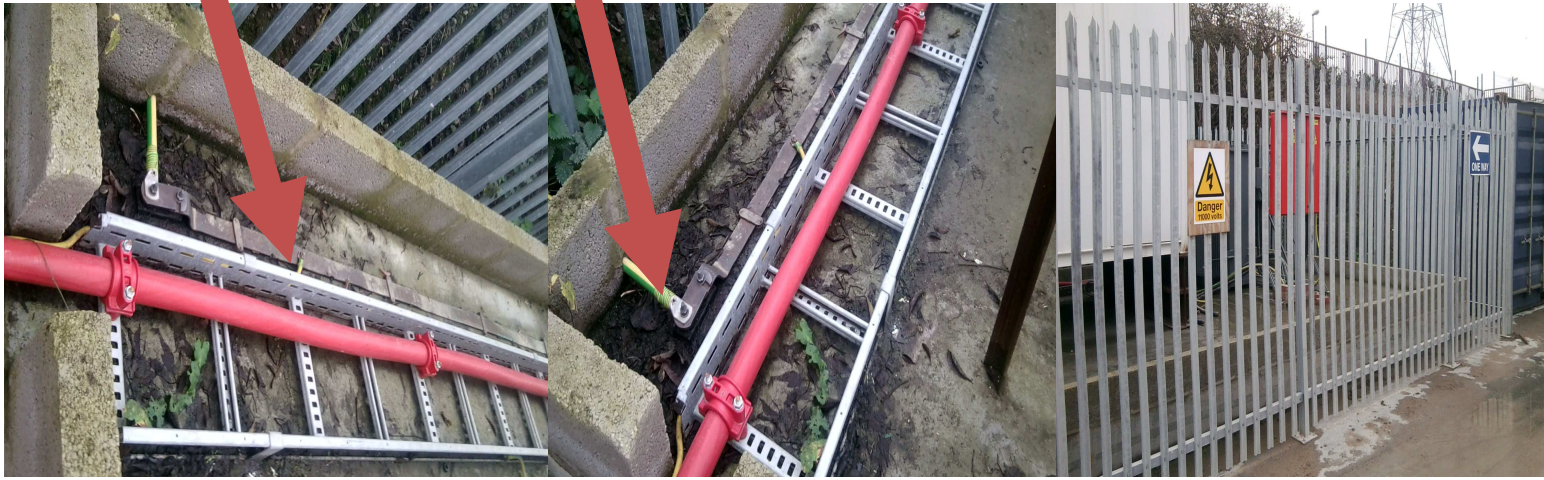
During a recent electrical safety inspection by one of the Electricians, he noticed that copper and earth cable had been stolen from a transformer on MVB JV site 3 (CEMEX) inside the power sub-station. The electrician followed the procedure and immediately reported the situations to his foreman. The stole items were immediately replaced.

- The earth cables, copper, were missing between the transformer and the main distribution unit.

- Theft of essential electrical components.
- There might have been easy access to the site.

- Improve security monitoring around all sub-stations on MVB JV project and sites in general.
- Electrical checks are now carried out daily by competent electrical staff.
- New method of padlocking substations has been implemented.
