Health & Safety Alert No. 4

MGJV

Friday, 10 June 2011

Eye protection

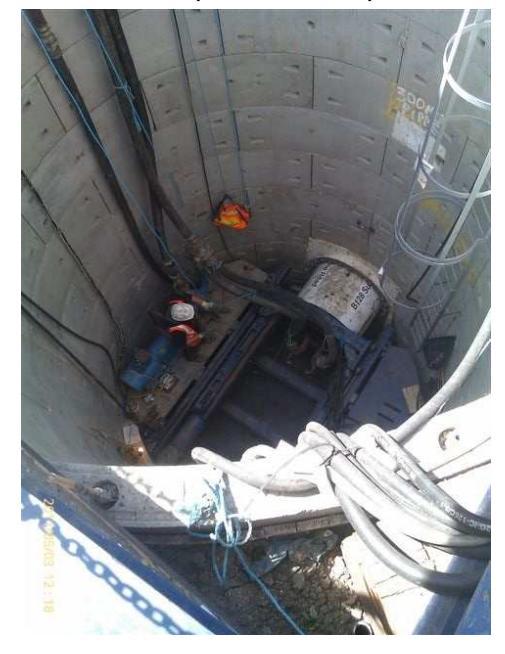
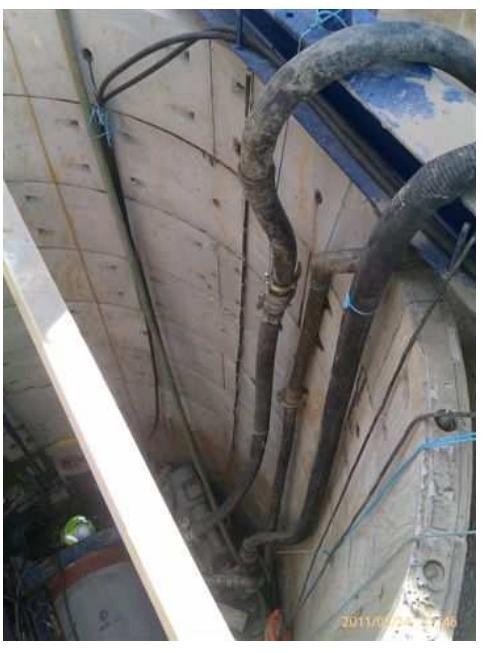
The operative was working at the bottom of the drive shaft on Sudbourne Road. His role was to monitor tunnelling equipment. As shown in the photographs, there are 100mm diameter flexible pipes that go down the side of the shaft, feeding and removing water from the tunnelling equipment. These pipes are rated to 16 bar, and the normal operating pressure is 0.5 bar on site. The flexible hose is connected to the metal coupling by crimping. The rubber hose came off the metal tail, and therefore the pipe discharged its flow into the shaft. The water hit the bottom of the shaft and bounced up into the injured person's face, getting dirt in his eye. The tunnelling operator immediately switched off the flow. First aiders washed the eye, it was still irritated the next day, but when checked out at the local hospital it was reported to be fine.

The risk assessment for the task is to be reviewed. Flexible pipework entering a shaft is to have a clamp fitted as an extra precaution to manufacturer's recommendations. The pipework is to be more regularly inspected under the PUWER regime. Since the incident, the site has been visited by the client showing the importance of communication with the client in an accident investigation. The project is also reviewing the need for safety glasses and goggles. The need for operatives to wear safety glasses should be more widespread and considered within task specific risk assessments.
