## Foreword

# Learning opportunities

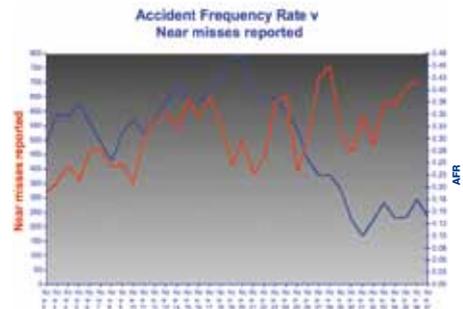
The correlation between AFR and Near Misses is shown on the graph above and clearly demonstrates the relationship between AFR and near misses.

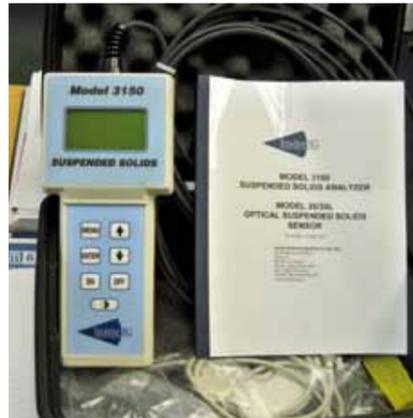
Tunnelling Services have acquired a device for measuring Total Suspended Solids (TSS). We can now test the effectiveness of our settling tanks, filters and separation equipment prior to discharge without waiting for analysis results from a laboratory. It is simple to use and will help demonstrate compliance when we are discharging to surface waters or sewers.

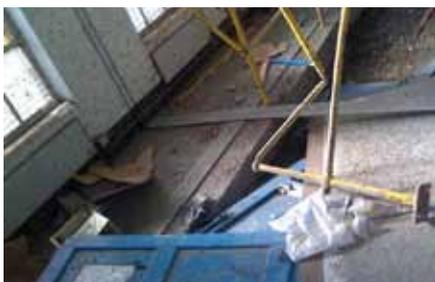
Scene inside the pumping station after the explosion

Whilst cutting hand-railing as part of a decommissioning activity in a pumping station, an explosion occurred injuring two operatives. The decommissioning required the infill of wells with foam concrete. In this project, Incinerator Bottom Ash (IBA) was used as the aggregate. After investigation it was determined that aluminium particles in the IBA can react with the water and cement contents of the concrete to generate hydrogen gas. In this case the gas appears to have built up beneath metal flooring and is likely to have been ignited by a spark created by a grinder.

- The use of foam concrete containing IBA is no longer permitted for Barhale projects. Only foam concrete using inert materials will be permitted. Examples of inert materials used in foam mix designs include sand, gravel or crushed stone. Always seek confirmation from the Supplier that the materials are safe to use.
- Contact your Supplier for clarification if you are unsure of the ingredients used in specified mixes before authorising use.

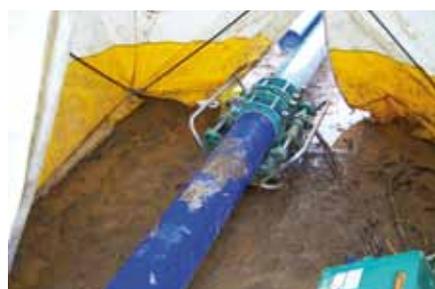
Butt welding working conditions

Barhale operatives were in the process of placing a 12m length of 250mm diameter HPPE pipe onto the rollers to carry out a butt welding operation. This operation had been ongoing for 3 days and

both operatives were trained and experienced in the use of butt fusion equipment. However due to wet weather conditions, the IP had removed his gloves to handle the pipe and lifted it by placing one hand in the open end of the pipe. When the pipe was placed on the rollers it appears that the other operative slipped, pushing the pipe forward. As the IP attempted to remove his hand, his finger became trapped between the pipe and the shaver plate on the butt fusion equipment; this resulted in the injury.

- The risk of injury from a hand being trapped between the pipe and the butt fusion equipment had not been identified.
- The change in conditions was overlooked by the site team, removing the opportunity to stop, report and discuss alternative safer methods of work.
- The IP removed his gloves to manually handle the pipe due to the weather conditions which increased the severity of his injury.
- Risk assessments need to assess changes brought about by different weather conditions.

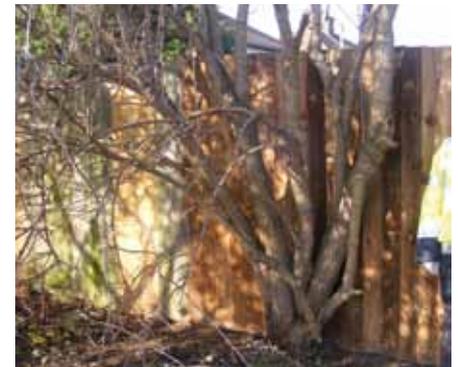
Position of tree contributing to difficulty of manual handling

While moving a fence line a ground worker pulled a muscle when manually removing from the ground a concrete post 2.3m long and weighed approximately 50kg. Two factors that contributed to the cause were the post was located by a tree, an

obstruction that made the operation very awkward, and the other operative had an existing back condition that prevented him from effectively lifting. Consequently while restraining the post the man doing the lifting strained his neck and shoulder resulting in him being off work for several days.

- Do not underestimate what are considered routine tasks, assess them for access and egress, slippery, wet conditions or obstructions
- Never allocate persons with limiting medical conditions to manual handling tasks.
- Individuals must make known to their line managers any existing medical conditions or limitations which could affect their ability to carry out their work safely.
