## High Winds – Securing Site Cabins Action Required

### Incident

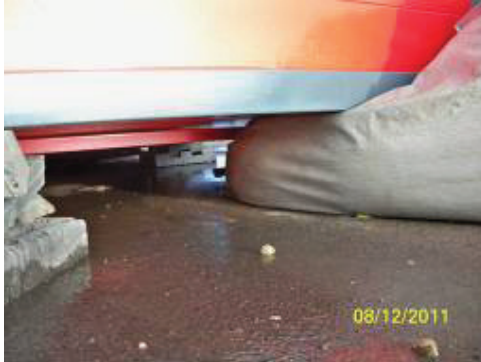
The circumstances of this incident would have been far more serious had the Contractor not fallen over or if the cabin had not landed on the 'bean bag safety cushion'.

**Photo shows:** View at south-east corner: Site cabin landed on “bean bag safety cushion” and provided approximately 400mm void between the base of the site cabin and the ground level. We understand that the injured party was under the site cabin at this location.

On sites where Jacobs staff have a presence we should, in conjunction with the Contractor, review the processes that have been put in place to ensure that all Site Cabins/ Containers have been adequately constructed and are adequately anchored or secured together to withstand extreme weather conditions.

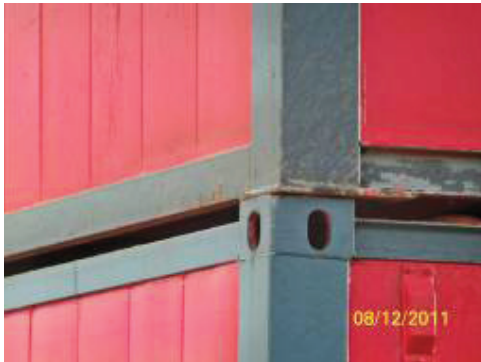
The investigation is on-going, however, it is understood that the cabins were not secured and anchored to the ground. Further details will be issued when they are available.

**Photo shows:** View of remaining cabins immediately after incident – cabins are not physically connected or secured to the ground.
