Global Safety Stand Down (GSSD) Briefing for worksites

GSSD #7: 2011 Struck by moving object

London, UK

Skanska UK

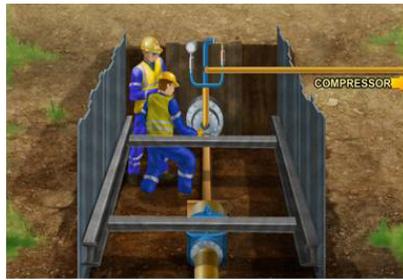
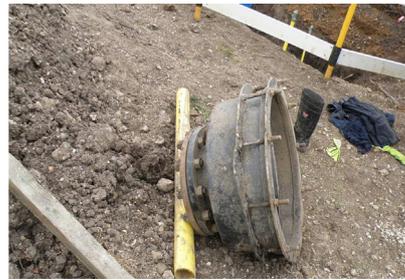
Shaun Maslin and another operative were in the excavation at the time of the incident. A third operative was on site assisting in the operations. The compressed air for the test was provided by a compressor, placed 15m (50ft) away. The ends of the steel pipe were sealed by temporary end caps. The end cap which blew off measured 700mm (2ft 3in) in diameter and weighed approximately 100kg (220lb). The end cap was held in place by a compression collar which provided a gas seal, but is not sufficient to hold the end cap in place under pressure. This was done by a 3.3m (10ft) long wooden strut, placed between the end cap and the new section of pipe.

During the pressure test there was an air leak, to locate the leak detection fluid was being applied to one of the end caps. To apply the leak detection fluid around the edge of the end cap Shaun Maslin stood in close proximity to the end cap. Shaun requested that his team mate retrieve spanners from the works vehicle. Whilst the team were waiting for the spanners to be returned the wooden strut failed and Shaun was struck by the end cap as it was blown off the pipe. The end cap traveled 15m (50ft) before it came to rest. The trench support system was severely damaged by it as if flew from one end of the excavation to the other.

1. A site specific hazard assessment including a written test procedure was not produced for the pressure test.
2. The anchorage system was not designed or constructed in accordance with established design standards.
3. The safe system of work and required standard for the pressure test was not discussed or briefed to the whole team.
4. The team leader (Shaun Maslin) did not have the full qualification to undertake work on large diameter gas mains.
5. The work post construction and prior to the pressure testing was not inspected or supervised by Alliance staff.
6. The team were not provided with a design from which to construct the anchorage system in accordance with established design standards.

The anchorage system was not designed in accordance with the engineering standards. This resulted in the temporary supports and the materials used to prevent the end cap blowing off during the test not being constructed in accordance with NGG (Gas industry) standards and subsequently failed during the pressure testing.
