HEALTH AND SAFETY ALERT No. 9

Fatality – 11kV electrocution

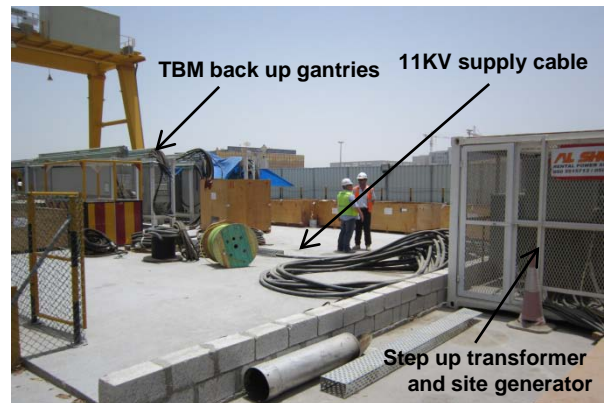
Figure 1. TBM back up gantries connected to step up transformer .

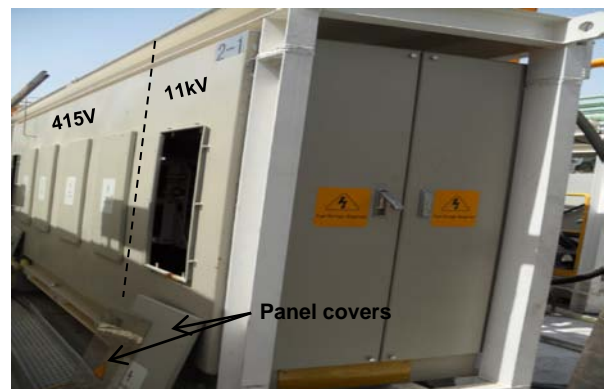
At 11:00 am on 2 June 2012, a fatality occurred on the Strategic Tunnel Enhancement Programme (STEP) Contract T-01 when a worker was electrocuted when he attempted to remove a high voltage (11 kV) cable connected to a tunnel boring machine (TBM) switch transformer gantry. The gantry was in the process of being removed and replaced due to a faults on two control transformers. Before removing the gantry the electrical cable connections (415V and 11kV) needed to be disconnected. The supply to the 415V side of the gantry is isolated at the gantry control panel and the 415V outgoing cables were disconnected without incident. However, the 11 kV supply to the switch transformer had not been isolated and this was not communicated to all workers carrying out the task. Whilst the supervisor and other workers were taking a break and waiting for the isolation to be made an assistant mechanic removed the outer steel panel and inner polycarbonate screen using a power screw driver and attempted to remove the live 11 kV cable connection using a spanner. He was fatally injured at the scene after suffering an 11 kV electrical shock.

Figure 2. Switch gantry with 11 KV steel panel and polycarbonate screen removed.

- STEP suspended all TBM operations and issued a list of action items to the contractor that had to be fully addressed before work was permitted to recommence, e.g. review and revise the permit to work system
- STEP commissioned an independent electrical engineer experienced in HV and LV installations to review the safety of the site electrical equipment and the electrical equipment on the TBM gantries
- STEP required the responsibility given to a subcontractor for tunnelling operations to be removed and transferred to the main contractor

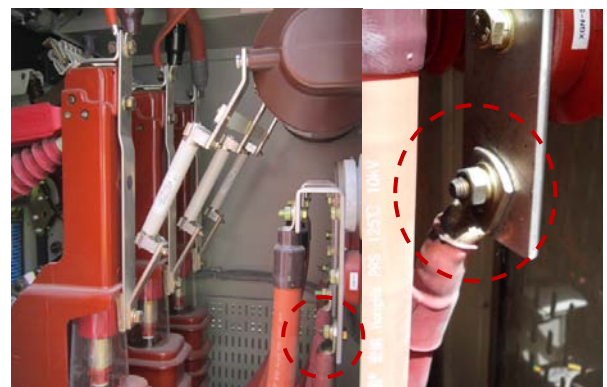
Work had commenced on a high voltage electrical system without implementing a formal permit to work as described in the contractor's health and safety plan.

Figure 3. 11 kV supply connection to the switch gantry.
