# SAFETY ALERT #025

**Title: Grinder Fatality**

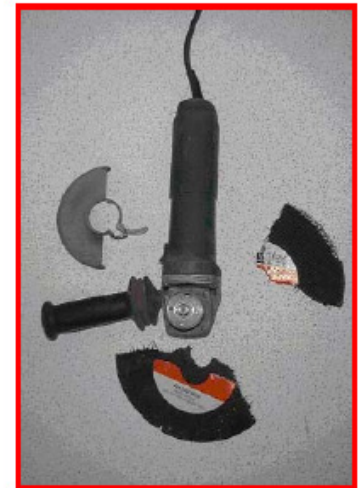
Angle grinder and disintegrated disk

A welder was carrying out maintenance on an excavator bucket. He was using an angle grinder to prepare surfaces for welding when the disk disintegrated. The hand-held angle grinder was fitted with a 230 mm diameter cutting-off wheel and when it disintegrated, fragments penetrated the victim's chest and abdomen. He was rushed to hospital by rescue helicopter but died the same day.

Initial inspections show that the grinding machine and cutting disk were not compatible. In addition, the grinder was not fitted with a guard.

Grinding machines and abrasive wheels should always be used in accordance with the manufacturer's instructions. In particular:

- Always ensure the maximum speed (the no load rpm) marked on the abrasive wheel is greater than the rated speed of the grinder.
- Do not use grinding wheels that are larger than the maximum recommended size, or worn down wheels from other grinders.
- Never use grinding wheel power tools without the wheel guard attached to the tool and positioned for maximum safety.
- Store and handle abrasive wheels with care and inspect them for chips or cracks before installing. Do not use any wheel that may be damaged.
- Cutting disks should only be used for cutting only and not for grinding purposes.
- Training on 'safe use of grinding machines' to be provided to all personnel using this equipment
