## TITLE: Service Strike – Sewerage Pipe

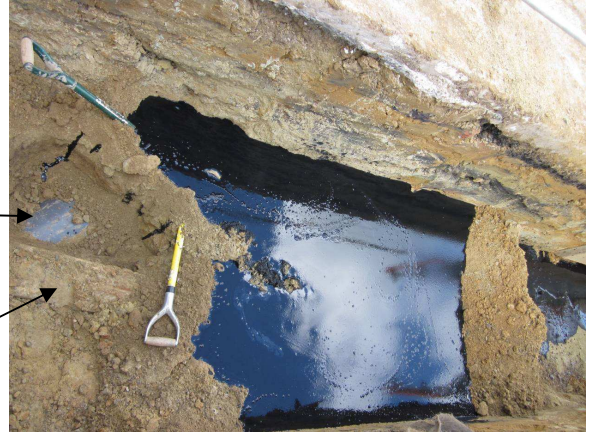
On the 8<sup>th</sup> August 2011 an unexposed sewerage pipe was cracked by stones/rubble during excavation by a 360 excavator. This resulted in a spillage of sewage, Thames Water isolated the pipe whilst repairs were made.

225mm PVC single walled sludge pipe

Power cable protected with tiles

- 12 Where unexpected services are uncovered STOP WORK until the risk assessment, method statement and Permit to Break Ground has been reviewed and re-briefed.
