### Diesel Leak from Portable Toilet

A defective fuel pipe located at the rear of a Garic portable toilet – the **Garic 855 Solar Loo** – enabled approximately 1 litre of diesel to escape to ground due to inadequate containment within the Garic unit. These units are not compliant with The Water Environment (Oil Storage) (Scotland) Regulations 2006.

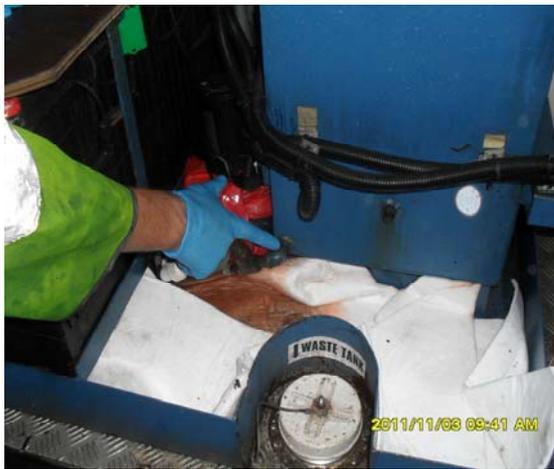
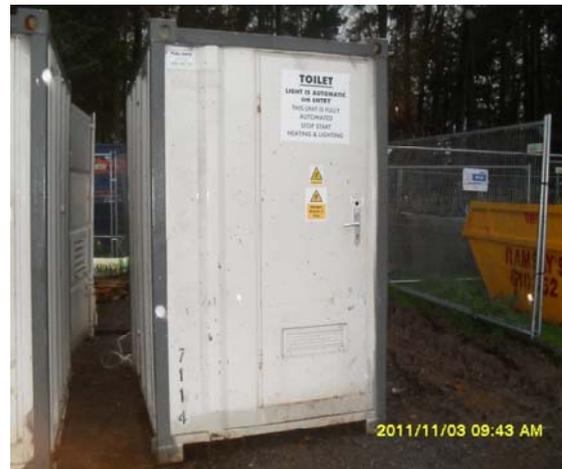
A strong smell of fuel was evident during an early morning inspection and it became apparent that the source was an isolated leak within the rear of the portable toilet block.

A fuel bund, which was full of diesel when discovered, was of insufficient capacity to retain the contents of the tank which had leaked due to a defective elbow fitting from the fuel line (see Photo). The fuel leak was exaggerated due to the unit not being placed on level ground. This also enabled the excess fuel within the bund to overspill on to the tarmac area of the compound.

- The diesel spill was contained locally and cleaned up with absorbent mats and booms. A bio-degradable oil digester was used to remove residual hydrocarbon from the tarmac.
- Inspection of all similar units confirmed that each was non-compliant with the oil storage regulations due to inadequate bunding. It was also noted that each pipe assembly was of poor construction.
- All the units were drained of diesel and withdrawn from service.
