Dangerous Occurrence: Piling Platform Failure at Battersea Reach, London

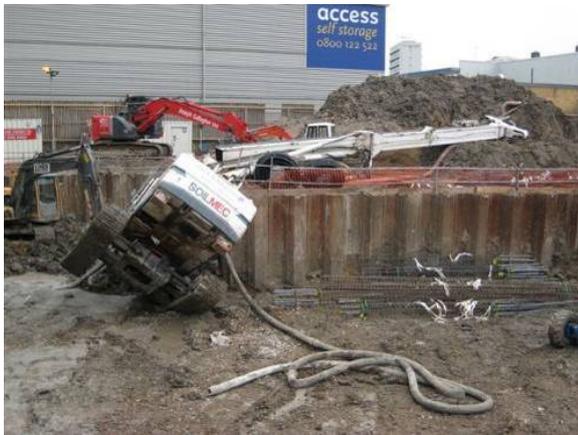
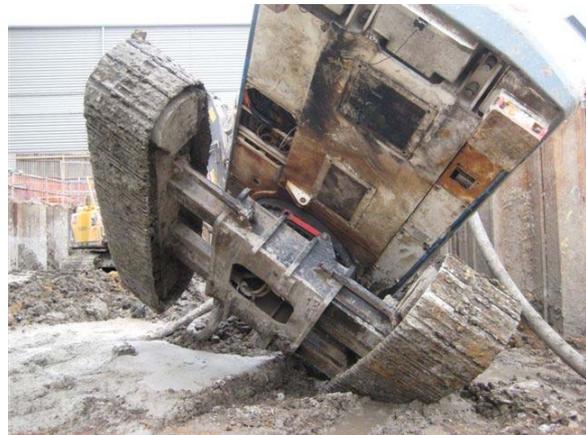
Rock and Alluvium were working a Soilmec CM70 rig on a St George site at Battersea Reach, Wandsworth, London on March 4th 2011 installing 600mm diameter CFA piles to depths of around 26m. Whilst drilling one of the piles there was a concrete blockage therefore the auger was back screwed out of the bore to enable the extension pole to be removed. As the auger was back screwed, the ground began to fail under the foot of the rig causing the rig to sink forwards and right towards the sheet piled wall. The rig operator tried to recover the rig by tracking back and then drilling back into the ground but this was unsuccessful. The piling platform failed under the front right hand side track and the mast folded over the sheet piled wall, coming to rest on the large spoil heap as shown in the photograph above.

- The piling platform was a maximum depth of approximately 300mm instead of a minimum required depth of 600mm in the area the rig sank.
- Crushed material used to construct the piling platform was not tested by a UKAS laboratory to certify that it met the specification of the piling platform design.
- The platform material contained a high fine content along with crushed brick and timber.
- The rig back screwed out of the pile when it was evident that there was a concrete blockage.
- This was the third pile over the duration of the contract where a blockage occurred and back screwing was required.

- Ensure that all piling platforms are designed within the specifications recommended by FPS (Federation of Piling Specialists)
- Ensure ground conditions are checked by a qualified and competent engineer prior to installation to ensure that an adequate foundation is provided for the platform.
- The platform should be maintained and remediated to platform design level where necessary for the life span of the piling activities.
- Ensure that the design is signed off by the independent checker after maintenance of the platform and a certificate issued to the piling team prior to the installing and operating the rig on the new platform.
