**INCIDENT TYPE:**

SAND FILTER LIDS BLEW OFF DUE TO HIGH WINDS

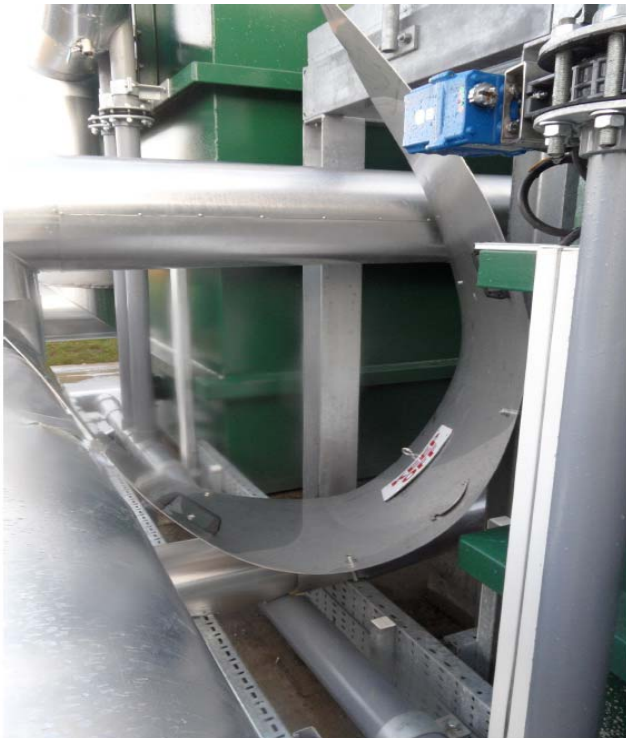
**Fig 1**

During the recent high winds a lid blew off the sand filter. Luckily, no one was in the vicinity at the time otherwise they may have been seriously injured. The tank lid can be seen in Fig 1 wedged in some pipe work, this blew approx 10 metres from its original position.

This will be determined by the manufacturer on completion of their investigation. In the meantime, I would ask that where similar equipment is fitted that such plant is checked to ensure that lids are properly secured and if any defects are noted, please report accordingly. Further information will be distributed when investigation is completed.

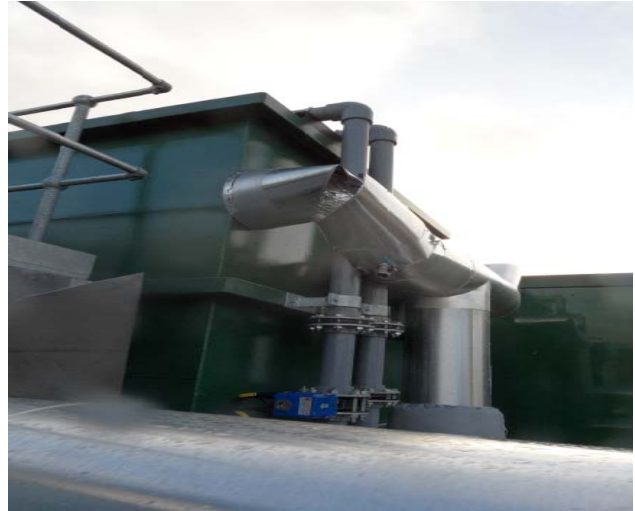
**Fig 2**

As can be seen in Fig 2 this caused damage to lagging on the SAF tank. Fig 3 shows where the lids were fitted.
