Laceration to finger while using a pipe cutter

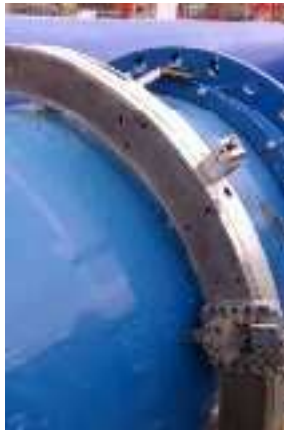
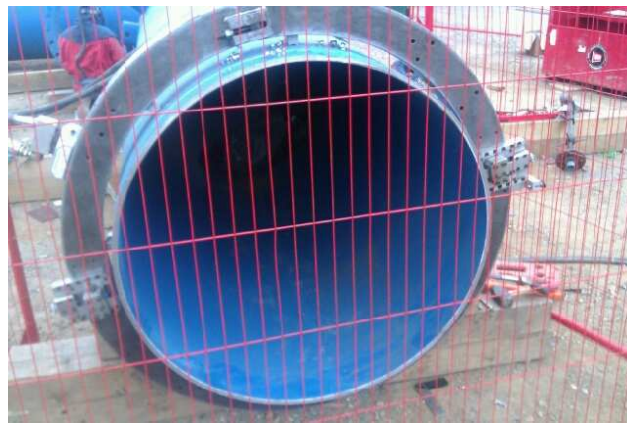
The operative was assisting another operative in setting up the split frame cutter to cut a 1000mm pipe section. The cut was almost complete with the injured party decided to remove some metal swarf from the top of the pipe section within range of the split frame cutter. The injured party received a deep laceration to his right index finger.

It can be seen from the photographs that the operative had to make a significant effort to place his hand in to the cutting blade.

The machine is now surrounded by herras fencing to provide a physical barrier to deter operatives entering the cutting area. However, this is not an inter-locked guard so if an operative does enter the area the machine will not stop working so is easily overcome.
