Operative suffered triple fracture to left Leg

Aggregate Industries Tool Box Talk Broken leg Harrogate

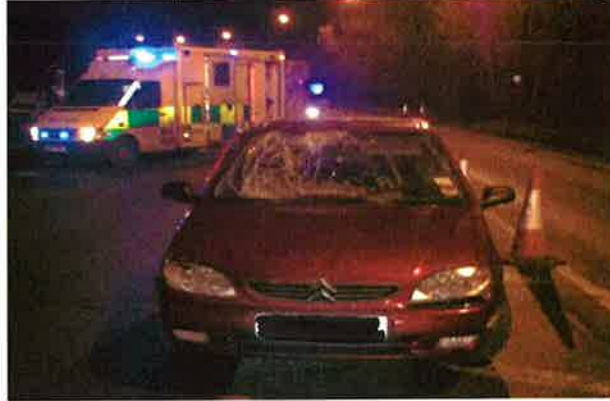
A Bardon Contracting gang were completing surface patching activities near Harrogate, on the night of the 21/01/2011, when the injured person (IP) was hit by a CAR whilst he crossed a live lane of traffic adjacent to the works area.

The gang were operating a mini-paver when the paver flight bar got stuck. The IP, who was employed that night to operate the screws for the machine, decided to cross the road in search of a piece of timber to assist in releasing the flight bar. The IP walked out into the live lane of traffic and in front of a car. The road had been reduced to one lane and the traffic flow was controlled via two-way traffic lights. The IP was hit by the car and then rolled up onto the windscreen, from where he was thrown clear and landed within 15 feet of the car in the works area.

- The IP sustained three breaks to his left leg.
- The IP's hard hat, safety glasses and gloves protected him against further injury.
- The IP was a sub-contractor working for an approved supply chain organisation. He was trained and competent, had previously been employed by Bardon Contracting and had work constantly with this gang for over six months.
- There was no works, storage or plant/vehicles situated at the opposite side of the road, and the operative had no need to exit the works area.
- The flight bars can easily be released by the machine driver, or with a 'tamper' bar tool which was in the works van.
- The IP did not inform the foreman or supervisor of his planned actions.

- Training and experience cannot protect you if you step out of the traffic management (safety control measure) that is designed to protect you.
- Prompt response and first aid by the gang was commended by the paramedics.
- STOP, THINK AND THEN ACT.

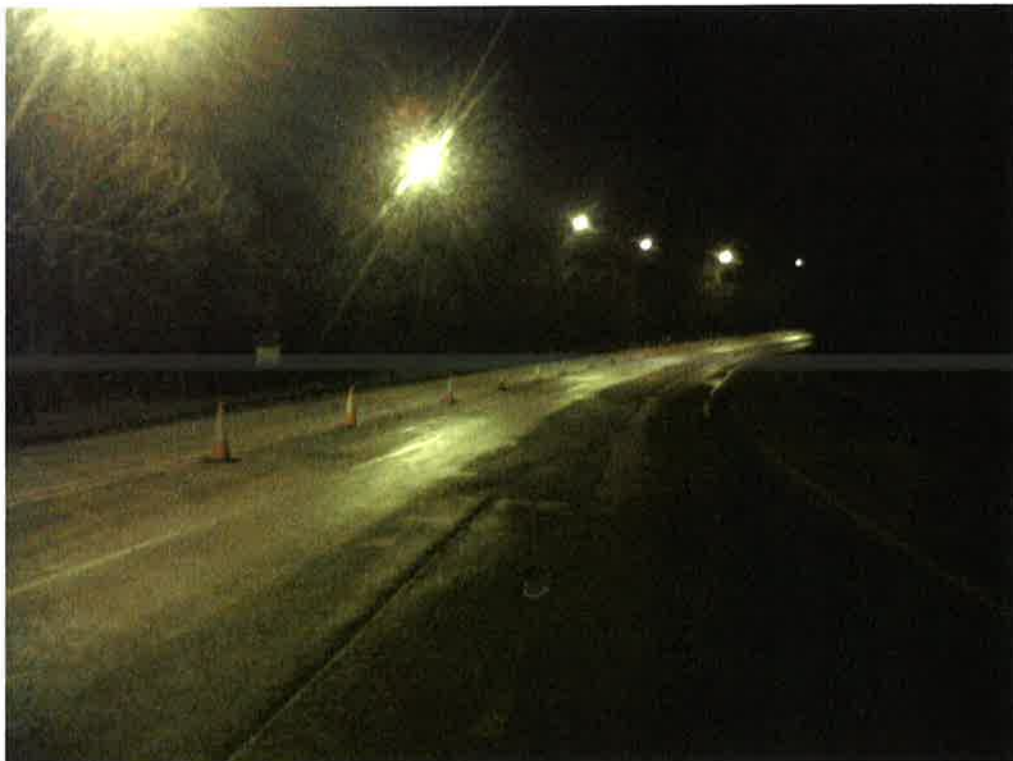
The incident occurred when the injured person (IP) decided of his own accord to exit the traffic management (a works area demarcated by cones and signs) and cross to the opposite side of the road, to look for a branch to help release a component on the paving machine which had become frozen due to the sub zero temperatures.

The traffic management had not been designed to have a pedestrian crossing, because the job did not require any storage of materials, plant, vehicles or welfare facilities on the opposite grass verge. Traffic management controlled areas must be accessed and exited via predetermined routes as far as is reasonably practicable. **Ensure all employees are aware of the hazards of the job and that the required behaviours are reinforced through key activities such as Safety Tour.**
