SAFETY BULLETIN – TRAPPED APPLIANCE CABLE

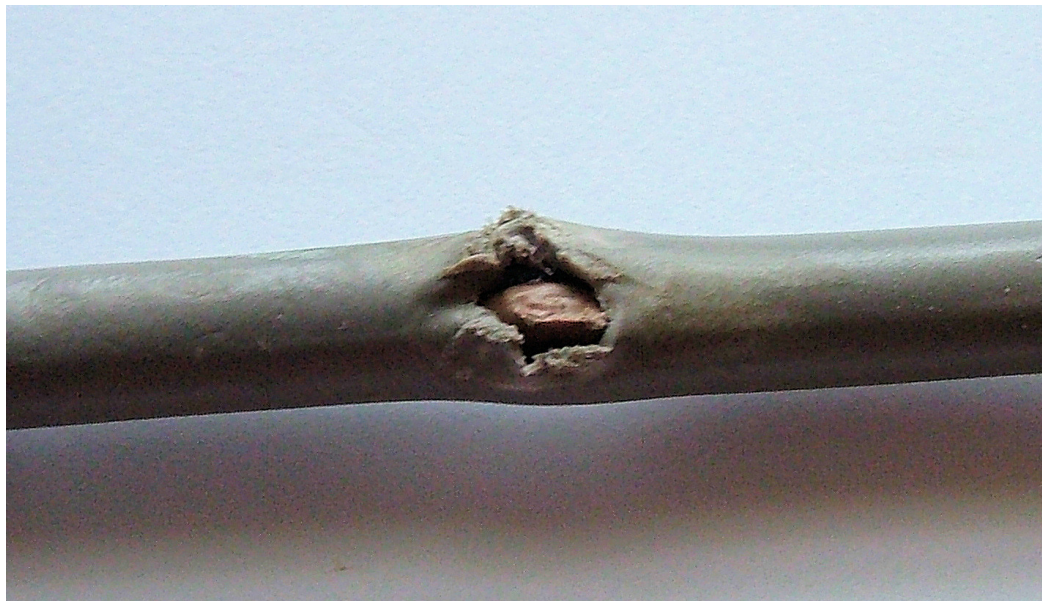
During recent inspection and testing of portable appliances in a Morrison Utility Services office, the cable of an extension Lead was found trapped beneath a metal filing cabinet, it was plugged in and turned on even though there was no appliance connected to the end sockets. When the cable was freed from beneath the cabinet it was found that the outer cable insulation had been completely worn away and the insulation on the now exposed live inner core was also worn almost to the point of exposing the live core.

It is fortunate that nobody had been hurt before this was found; this dangerous circumstance could have been the cause of somebody receiving an electric shock that could have resulted in burns and possible death.

Please make sure when furniture is being moved or installed that cables are not trapped beneath and please also make sure that any equipment not in use is turned off at the socket and if possible remove the plug
