Safety Alert

Member of Public Injury

Elderly Member of Public falls into MUS Excavation

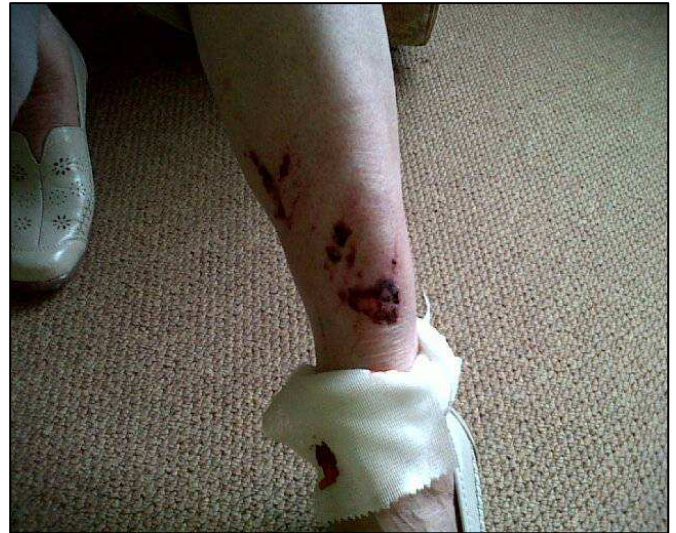
The investigation revealed that at some time over the weekend, the barrier system had been tampered with by persons unknown. This resulted in pedestrians being directed across an open excavation using the barrier boards as a bridge.

ALWAYS ensure that your site is set out correctly, and secured when you leave.

Consider other forms of protection in dense pedestrian areas (e.g. Heras fencing), accompanied by clear warning signs.

If sites have been closed/left for a period of time, regular visits will need to be made to check the site is still signed and secure

Take photographs of how you leave site so we can demonstrate that we left it secure.
