Safety Alert

LOST TIME INJURY INVOLVING BURNS TO HANDS, ARMS, NECK AND FACE

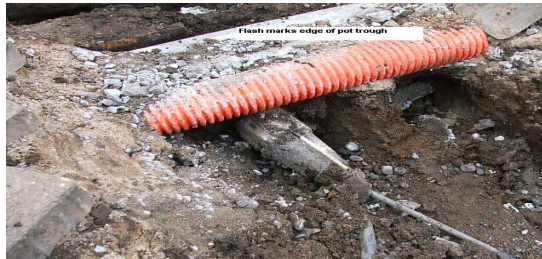
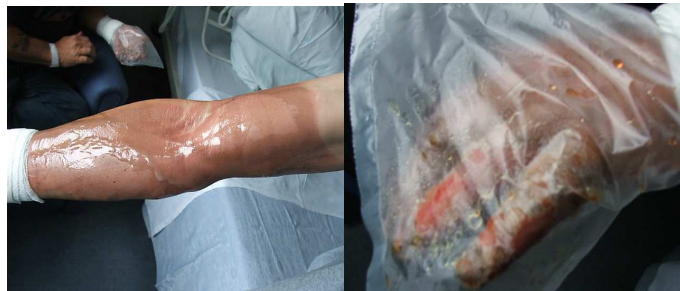
Operatives were excavating around a mains service breach joint to prove a Low Voltage main.

On disturbing the breeches joint, the outgoing cable arced, causing flash burns to both operatives. One operative's arms, right-hand side of his neck and face sustained flash burns, and another operative suffered severe burns to his left hand.

- Failure to identify / notice a pre-existing damage and to take the appropriate action.
- Failure of operatives to wear the PPE provided.

- Always be aware that unplanned events can happen.
- While working on site look for any visible or suspect signs of damage to existing services; and for electrical services listen for any sounds, crackling, bangs, smell of burning carbon or gases. If these are identified, stop work - make area safe, and contact your line manager.
- Make sure you wear your PPE as instructed.
- Make sure your PPE is suitable for the task.
- Nothing can be taken for granted, and you must be aware at all times that unplanned events can happen.
