SAFETY ALERT

Failure of hydraulic manhole lifter

MTS-SA-060 June 16

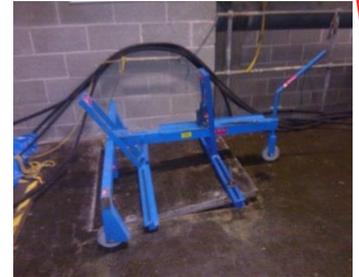
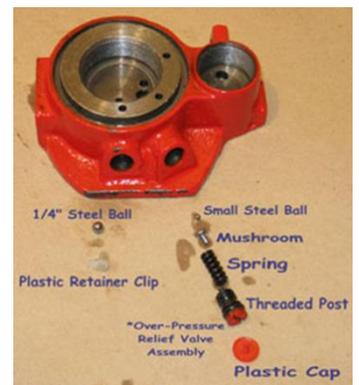
On 5th May 2016 MTS Cleansing Services Limited (MTS) were lifting a manhole using a hydraulic manhole lifter hired from Speedy Hire. During this operation one of the jacks became harder to operate. On the next operation of that jack, one of the four lifting keys attaching the lifter to the manhole failed. The investigation confirmed that the operatives were trained and had set up the lifter correctly. The equipment had all relevant LOLER and PUWER certification and had been given a pre-use check by the hire company in line with the manufacturer instruction supplied.

This failure of the relief valve allowed a force to be applied to the lifting key of over 200% of its design strength. This caused it to fail and bend the lifting frame as the energy stored was released rapidly.

1. Updating the LOLER examination and pre use checks undertaken to include the pressure relief valve and condition of the jack for leaks and oil contamination. This has been completed by Speedy and shared nationally across their business.
2. Updating the user training to include that a percussive force with a soft face mallet should be applied to free the manhole once tension has been applied to the lifter. This has been undertaken by MTS Cleansing and should be considered best practice.
