HEALTH AND SAFETY ALERT 10

FALLING ITEMS FROM STEEL REINFORCEMENT CAGES

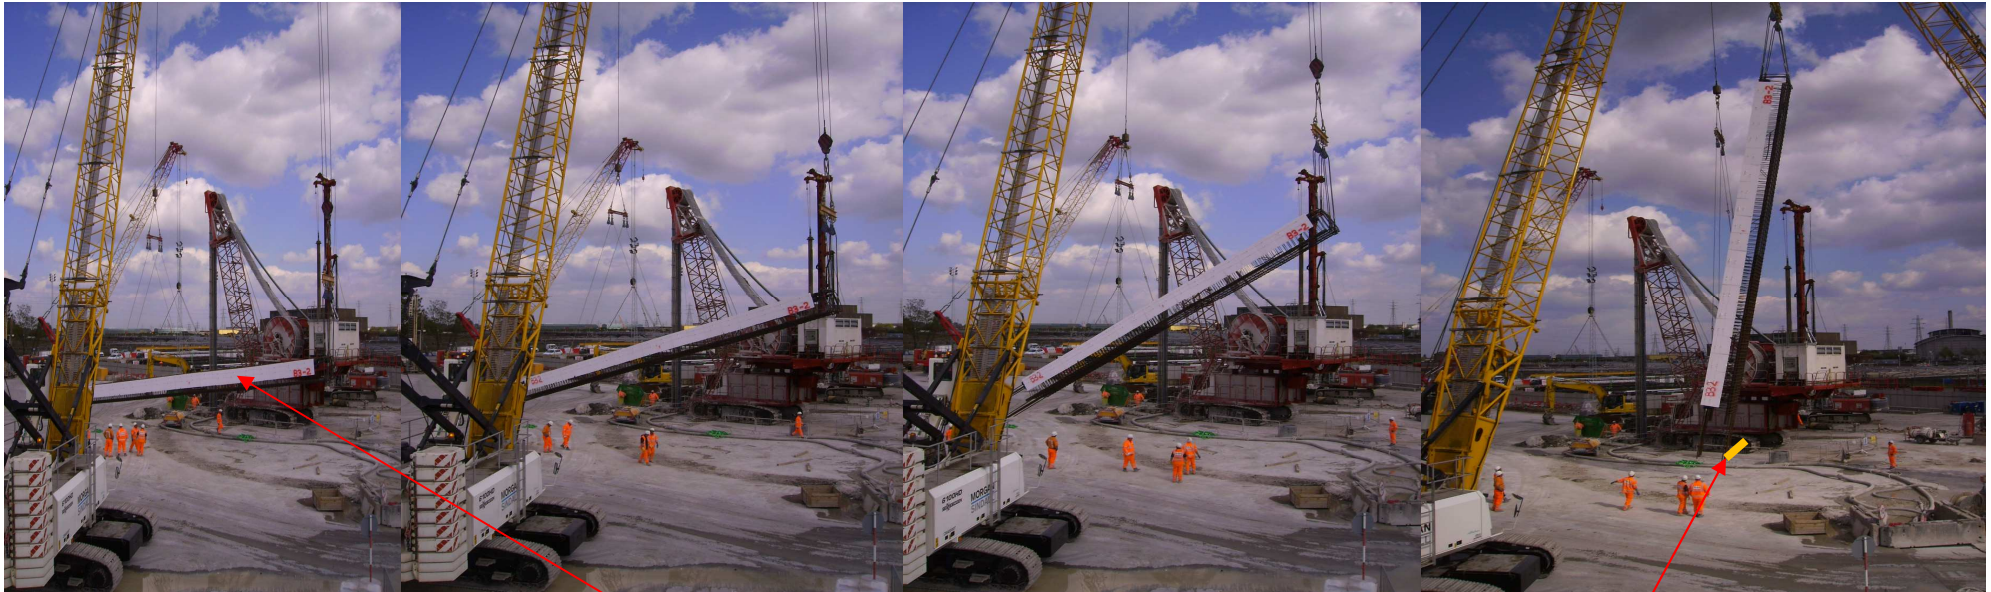
During the process of turning the steel reinforcement cage on the Diaphragm wall operations from the horizontal position to the vertical position so that the steel reinforcement cage could be lowered into the Diaphragm wall excavation a 200mm piece of 16mm diameter reinforcement steel bar fell out of the cage, on this incident no one was injured. However the potential was there to cause harm.

- The steel reinforcement cages are manufactured off site and part of the inspection process is before the cages leaves the workshop that the cages are inspected for loose items. The small off cut of reinforcement steel bar was not picked up on this inspection
- MVB have an inspection process to check for loose items and again this small section of reinforcement steel bar was not spotted
- During the turning of the steel reinforcement cage the 200mm section of steel bar fell to the ground
- The reinforcing steel bar was hard to detect as it's the same colour as the cages its self

- The steel reinforcement cage manufacturers have change their fabrication process to omit the necessity for the use of the small sections of the reinforcement bar to be used in the process of manufacturing the cages
- All tools and equipment used in the manufacturing of the reinforcement cages are to be painted with high visibility paint so that during the inspection process they are easily identifiable
- A renewed method statement has been briefed to manufactures workforce to high light the change in process of putting the cages together
- Awareness training has also be given to the manufactures workforce on the potential dangers of leaving item in the cages during fabrication which can fall from the cages
- MVB to visit the manufactures periodically to ensure that the renewed method statement is being followed .
