Failure of lifting equipment

Two incidents have occurred recently at our construction projects whereby the lifting equipment failed whilst in use manoeuvring a large waste skip. The skip (approximate weight 4 tonne) is the high sided skip commonly found on site (pictured here in the background).

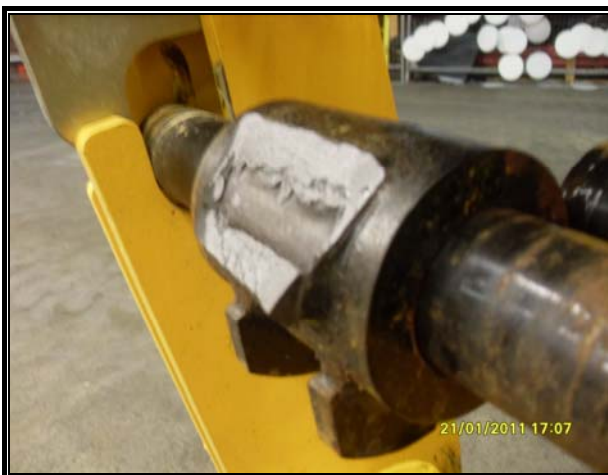
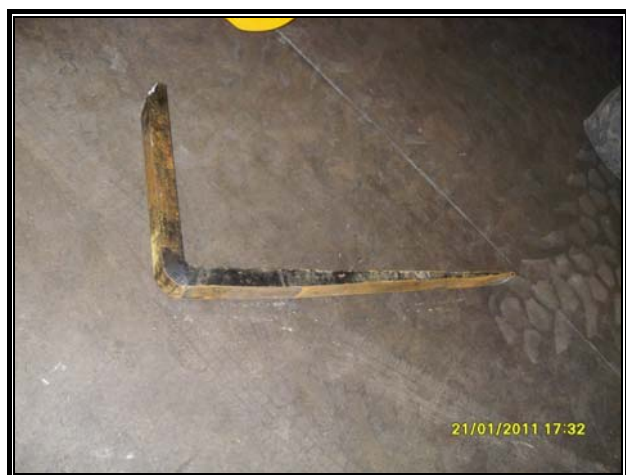
At the time of both incidents the skips were being moved by a telehandler. The telehandler was positioned in front of the skip and lifted one end of the skip. It has then attempted to push the skip using the rollers on the other end to roll it. It is thought that the loads are increased on the forks because they are positioned near to the strengthening beams that run laterally along the base of the skip, therefore tying the forks and not allowing lateral movement

- **Telehandlers must not be used on any VINCI project to move this type of skip.**
- Telehandlers are not designed to push / pull skips in this way.
- The forks are designed for vertical loads, not horizontal loads.
- Any movement of these types of skips should be undertaken by the delivery lorry, with its dedicated lifting arm.
- The telehandler, forks or other critical components could become damaged (and not recognised) and could fail on a subsequent lift or at any time in the future.

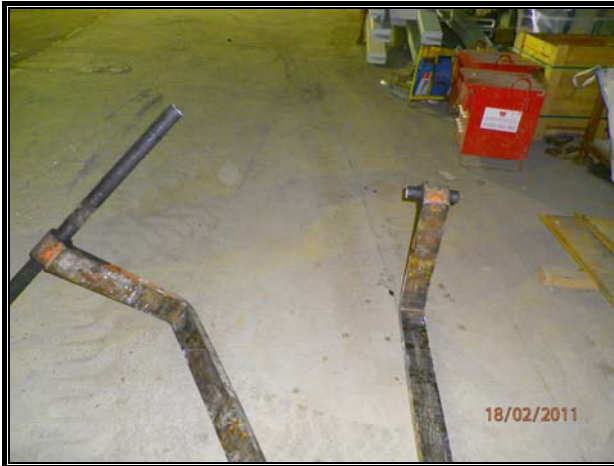
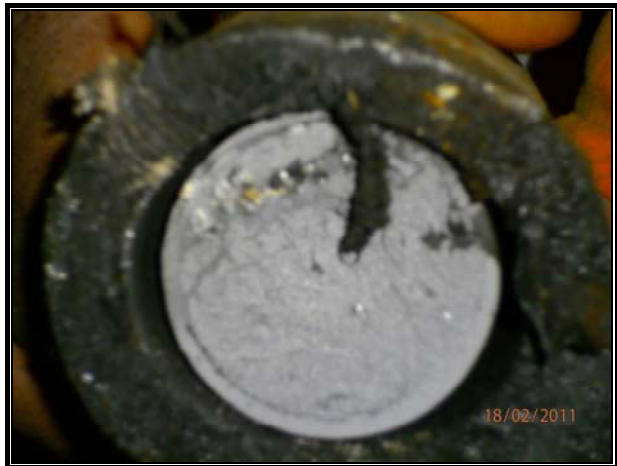
It is believed that both failures have been caused by massive lateral loads being imposed by the action of the vehicle and the pushing of the skip.
