## HEALTH AND SAFETY ALERT N°23

### AN UNCONTROLLED LIFTING OPERATION

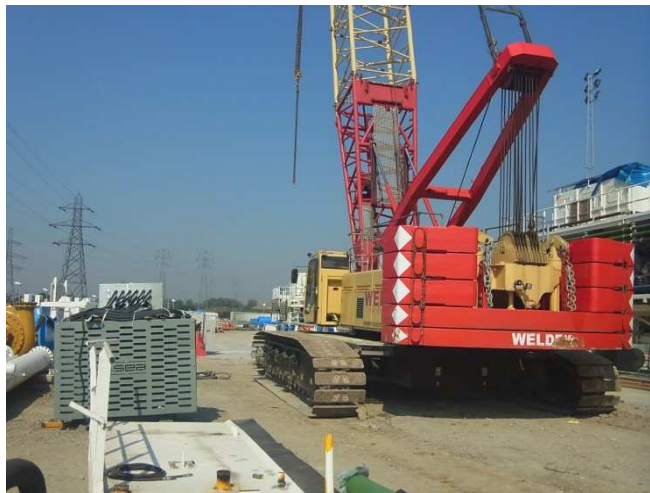
During a lifting operation on a MVB site 4A the slinger signaller had attached the chains of the crane to a compressor which was to be lifted to a position where it could be towed to another location, site security requested the slinger signaller to complete the paperwork to remove the compressor from site.

It was at this time that the crane driver under no further instruction from the slinger signaller continued with the lift.

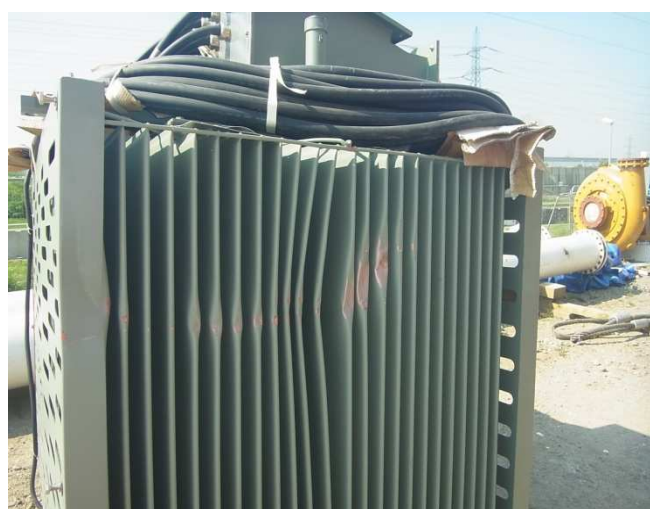
Whilst continuing with the uncontrolled lift, the crane driver has slewed to place the compressor in a location to be towed, in doing so he has hit the cooling fins of the transformer with the counterweight of his crane.

The cranes counterweight has a 2.70 m overhang from the track bed of this crane, which has not been taken into consideration whilst slewing.

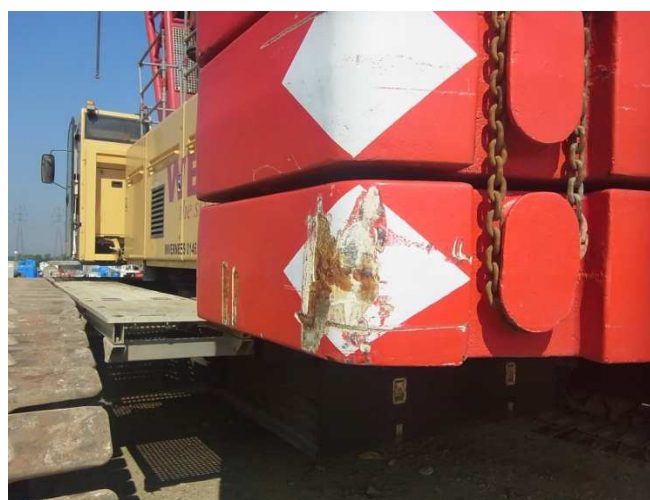
- The investigation has identified the change in controls
- The crane driver should not of continued with the lift without any instructions from his slinger/ signaller
- The security guard should not of interrupted the slinger signaller during a safety critical activity
- The slinger signaller should not of started his task without the paperwork being completed, therefore removing the need for the security guard interrupt the sequence of events

- No Lift to carried out without the direct instruction from the slinger/signaller
- The slinger/signaller is responsible for initiating and directing the safe movement of the crane.
- On all sites, lifting operations should be carried out to a specific lift plan, on the small more compact sites it is especially important for the slinger/signaller and crane operator to be aware of the crane footprint and slewing radius .
- MVB doesn't tolerate operatives working without a lift plan or deviating from a lift plan
