HEALTH AND SAFETY ALERT No.22

UNCONTROLLED MAINTENANCE OPERATION

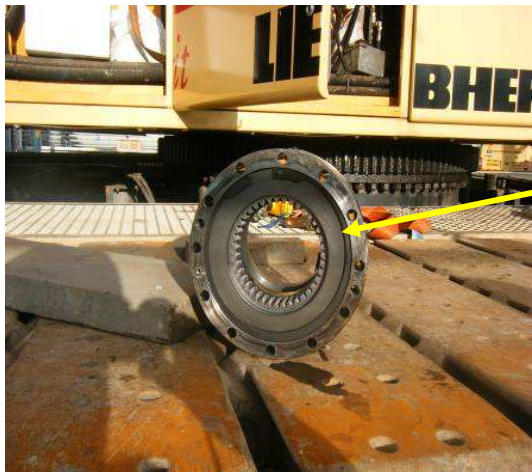
The Failure to follow the correct maintenance procedures by a visiting engineer caused the Winch rope brake device to become separated from the 200 tonne crawler crane brake drum housing.

The brake drum once separated from the main brake housing allowed the winch rope drum to free wheel, allowing for the uncontrolled descent of 7 tonne hook block which came to rest on the ground adjacent to the loading hopper.

The Hook block travelled approximately 5 meters before coming to rest, fortunately there were no personnel injuries or property damage, however the potential for a serious incident was there.

The investigation for this incident showed that the maintenance fitter attended site without contacting the site office and therefore, there was no control over the operation, no risk assessment, no method statement checks were seen. The maintenance fitter didn't follow his companies' procedure for removing the winch brake drum.

All future maintenance operation personnel should not be allowed onto the working area until they have contacted the site management team and discussed the methodology of their planned work, so that site team can ensure the necessary arrangements for a safe system of work are in place prior to any maintenance operations being carried out, reviewing the risk assessment to ensure it is suitable and sufficient to cover the task.
