SHEQual Bulletin

“False” Engagement of Tipping Hooks on “Builders” Skips

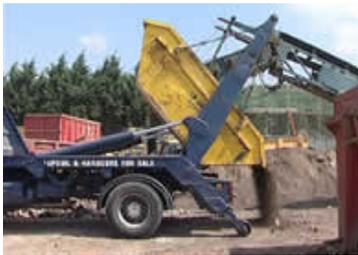
Photograph 1: Typical lorry borne skip tipping-out process

To tip-out a skip, the process is similar to off-loading except that a pair of tipping hooks, which are mounted towards the rear of the bed of the lorry, are raised and as the skip is pulled over them they engage on the tipping bar on the end of the skip near its base. As the lifting arms continue to rotate, the hooks hold the front end of the skip such that it begins to rotate and eventually reaches a near vertical position causing the load to slide out of the skip (see photograph 1).

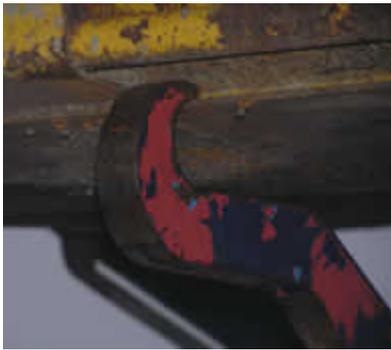
There are no nationally established standards (e.g. British Standards) for the manufacture of this type of skip which are generally fabricated from steel plate. Often the base plate extends beyond the end plates producing a lip. A hazardous situation can occur if the tipping hooks fail to engage with the tipping bar but instead 'snag' on the lip (see photograph 2).

This false engagement of the hooks is not necessarily visible from the operating position and, superficially, will behave like a proper engagement until an angle of tipping is reached whereby the hooks are pushed off the lip. When the skip is no longer restrained it will swing-out over the back of the lorry, the momentum of which could lift the front of the lorry off the ground.

Photograph 2: Tipping hook snagged on base plate lip

The immediate risk is to the operator because of their close proximity due to the controls being typically positioned at one side of the lorry. Although there is not a nationally established standard, the Container Handling Equipment Manufacturers (CHEM) Association have produced a technical standard TS14 "Standard Specification for Skip Containers" which manufacturers should find useful. In Section 4.6.3 it states: "There must be no projection of the base plate in the area of the tipping hook engagement with the tipping bar thus preventing inadvertent hooking on the skip."

- This bulletin is briefed out to employees and subcontractors within their area of control.
- Delivery and collection of the skips comply with this HSE notification.
- Driver-operators are instructed to perform a visual check to ensure the proper engagement of the hooks on the catch bar during tipping-out.
- Driver-operators are instructed to routinely check skips and skip loader vehicles and to report any defects.
