Learning Bulletin – Member of Public – Fatal injury – This was not a TW incident

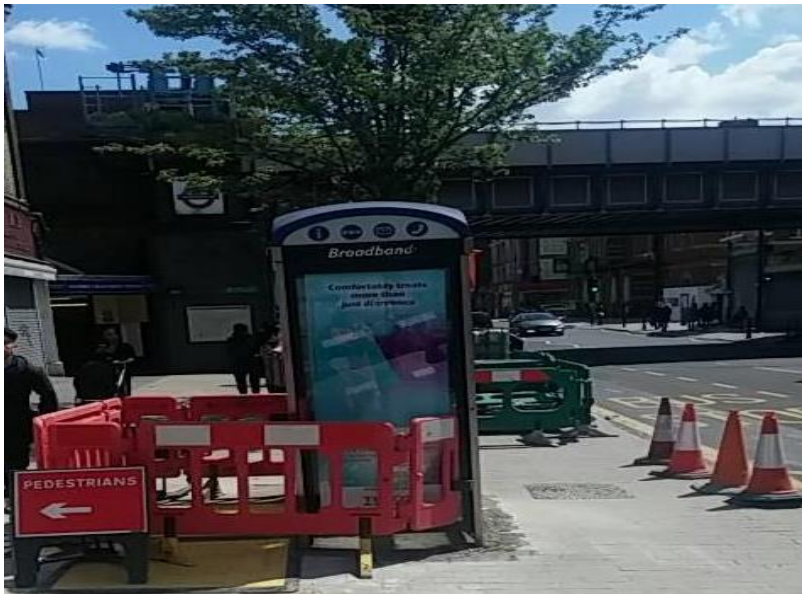
Dad-of-two fell head first into an excavation on site fatally wounding him.

The excavation site was dug up to carry out work on the water network

The injured person was walking past the site and fell into the excavation head first. There was no protection of the opening and did not have any signing, lighting or guarding in place at the time of the incident to warn passers-by of the dangers or to prevent them from accessing the work area.

- Ensure all excavations are covered using footway boards or road plates when unattended – If the excavation is too large for footway boards to be put in place, other means of protection MUST be sought
- Always provide the required width and clear access on footways – use kerb ramps for any crossings
- All Heras fencing and barriers must be double clipped and left secure
- Road and pedestrian signage must be correct for the site set up and in place to clearly show road users and pedestrians what to do
- If necessary use temporary lighting around the site to enhance visibility
- Always take photographs before you leave site
- If you are ever unsure, ALWAYS ask your supervisor before you leave site
