Progressive Collapse of Structure at Mogden STW

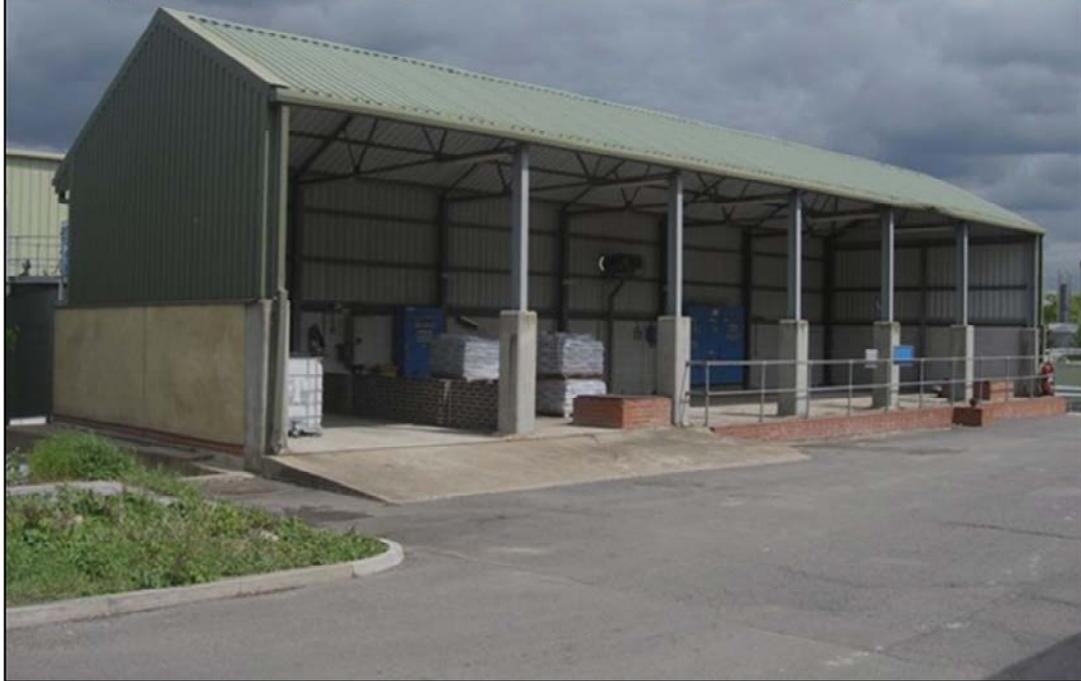
The truss along line 3 had been disconnected and was being lowered to the ground, as it did the truss caught on column B6 causing it to fall.

B6 fell onto the adjacent column which in turn fell onto the next column...in total 5 columns fell
