## Sheared Bolts Discovered on JLG Aerial Lift Boom Connections to Platform after Physical Inspection

**Lesson ID:** 2012-BNL-Aerial-0001

**Originator:** Brookhaven National Laboratory

**Date:** July 30, 2012

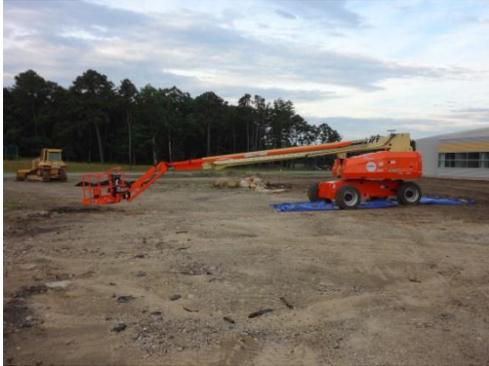
JLG Model 860SJ Aerial Lift

**Statement:** A JLG model 860SJ aerial lift was found to have all eight of its platform rotator attachment bolts sheared in half. This condition is not obvious during a visual inspection. Although there was no risk of the platform detaching from the boom the horizontal rotation capacity of the platform was severely compromised.

Initial inspection of the failed bolts noted that corrosion had formed on the failed surface of six (6) bolts indicating that these failures occurred sometime in the past.

- Temporarily take all aerial lifts JLG model 860SJ out of service until they can be inspected.
- Physically inspect the eight (8) 3/8-inch platform-rotator attachment bolts that surround the main center pin that holds the basket to the boom. If necessary raise the environmental protective cover.
- Visual inspections are not sufficient because the bolts are oriented vertically and appear intact.
- Follow the manufacturer's guidance for inspections but it is recommended to examine the bolts prior to each use particularly if the basket struck an object or was subjected to an external lateral force.
