# Safety Notice

## Failure of 'push-pull' formwork prop

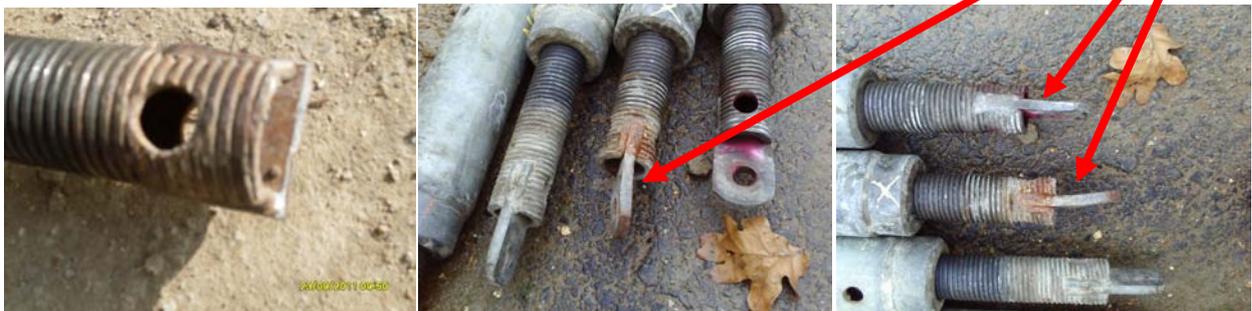
On inspection, the failed lug had a pre-existing crack across about 25% – 30% of its cross-sectional area, as shown below.

When other props on the site were inspected, several were found to have lugs that were bent as shown, incipient cracking being visible either with the naked eye or by carrying out dye testing.

It seems likely that the failure was a result of fatigue following repeated bending of the lug, probably during lifting or handling.

- 1) Inspect all props with connections of this type, and put out of use any which are found to have bent lugs or show signs of cracking.
- 2) An inspection regime must be established with all props inspected before use and at weekly intervals, where practicable.
