From: John Hennessy – SHE Director
Date: 9th December 2011
Ref No: SA2011-21
Version No: 1

Lifting Operations

On the evening of Friday 1st December on a major project in London, a 130 Tonne Tadano Faun ATF110G-5 Mobile Crane supplied by Baldwins Crane Hire, up-ended and came to rest on two steel columns.

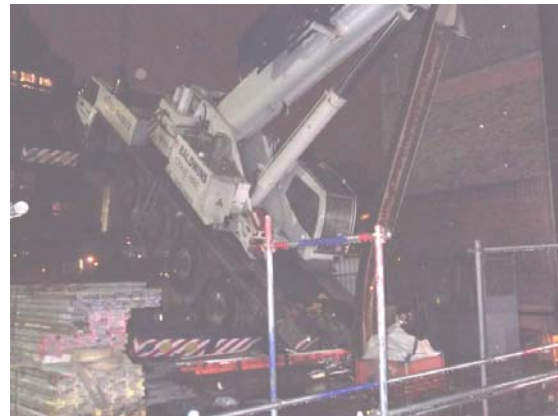
Fortunately nobody was injured and no major damage was sustained to either the crane or any element of the structure. The investigation is still ongoing, however early indications have revealed that human error was a main contributory factor.

Our initial investigations have revealed that there is **no fail safe device fitted, beyond the LMD** to capture wrongly entered data, as a consequence if the wrong counter weight detail is entered and exceeds that which has been actually installed, the audible and visual warning devices will not activate.

To ensure that the crane operator enters the correct codes into the LMD to identify the actual counter weight fitted, it may be necessary to amend your procedures i.e. pre-use check sheets to include a provision for secondary sign off.

We intend to discuss with the HSE changes required in the regulations to enforce the requirement for ballast sensors on all mobile cranes going forward.
