Safety Bulletin

Area 13 Telehandler accident warning

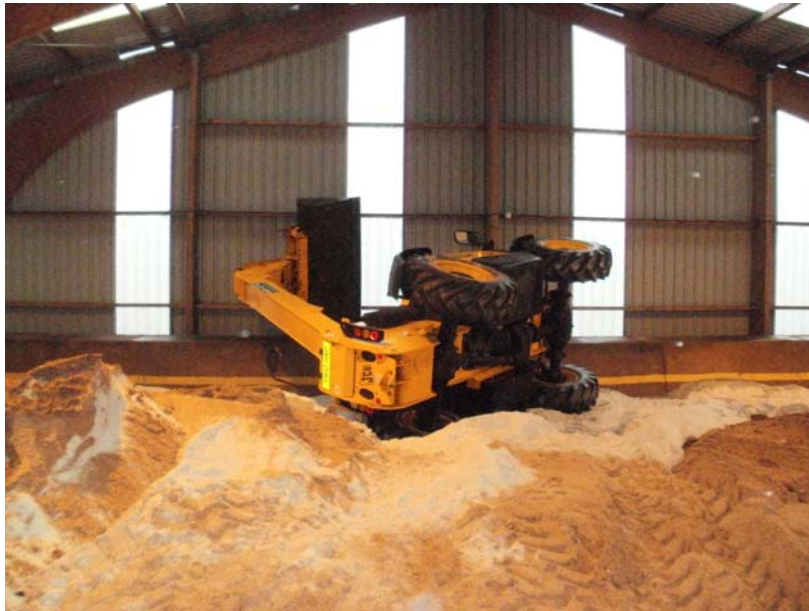
An incident occurred at Area 13 Low Hurst Motorway Compound on Thursday 8th December where a telehandler overturned whilst being operated on the top of the salt pile, carrying out maintenance duties.

Grit salt is a granular product and can be highly dangerous as it is very uneven and there will be voids within the pile, in fact this was the cause of the machine rolling over. The machine was travelling with the boom raised and due to the design of these machines, once the boom is raised they can become unstable if not on secure/even ground.

Management must identify if this unsafe working practice is being used in their locations and ensure that no-one operating a Telehandler, or similar machine, will access salt piles in this manner.
