MACKENZIE CONSTRUCTION

Health & Safety Alert

Bulletin No 02/12

Serious Injury to Dumper Operator

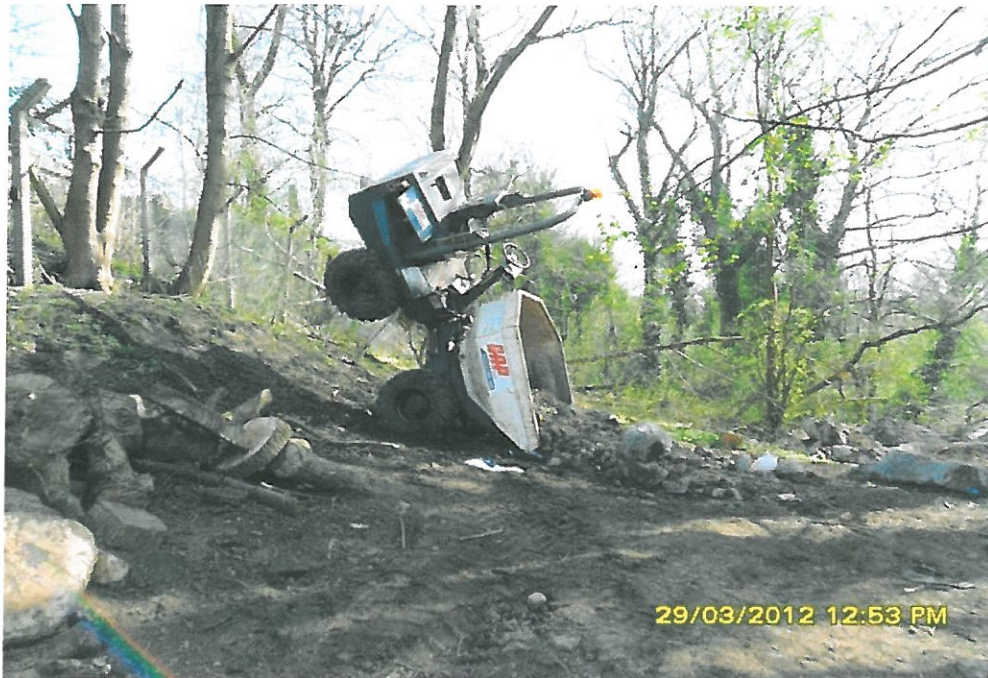
Recently one of Mackenzie's operatives was operating a forward tipping dumper (3tonne), taking concrete and spoil from an inlet chamber excavation on a site to the drop-down area. In order to complete his turning circle, he reversed the machine up a small but steep embankment, adjacent to a boundary fence. As he was changing gear to go forward, he touched the brake and the dumper over-balanced and tipped up to an almost vertical position. He was not wearing a safety belt and was thrown out and landed 6m in front of the dumper. He sustained injuries to his head and lower back. Investigations into the incident are ongoing.

- Review of Method Statements and Risk Assessments for all dumper operations.
- Refresher training for all operators of dumpers.
- Design alternative turning circle for dumper after loading.
- Level the land adjacent to site boundary to eliminate embankment as far as practical.
- Install barrier or stop to prevent dumper reversing too far.
- Check adequacy of dumper training for such operations.
- Safety briefing on use of dumper seat restraints and driving on slopes to all Mackenzie employees.

Mackenzie Contract Staff will attend a training session on Safe Use of Dumpers and assessment of maximum slope gradients.

- Wear safety belts
- Don't reverse up slopes or drive down slopes with a loaded dumper
- Be aware of maximum slope that dumper can safely be driven on (1:4)
- Check all terrain that a dumper is required to negotiate
