SAFETY ALERT

Telehandler Overturning

Dangerous Occurrence

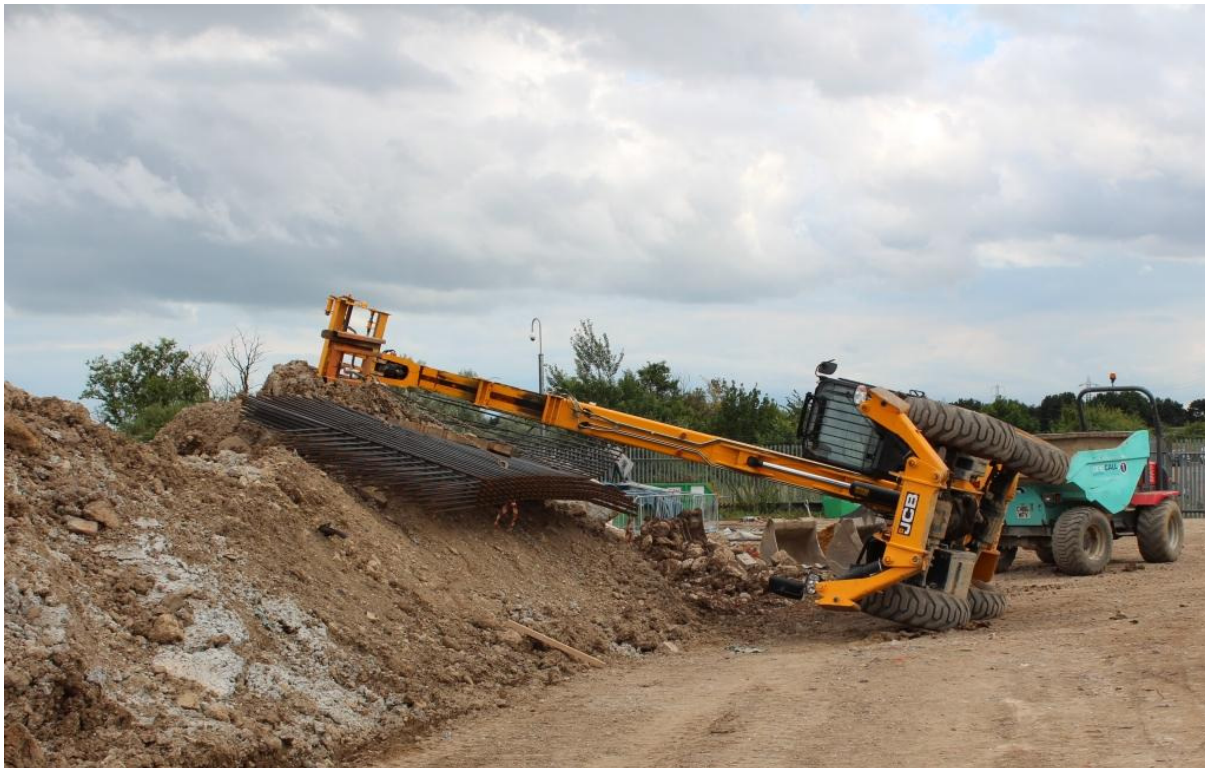
A telehandler forklift was operating at Bradwell power Station carrying a load of steel rebar (2135kg's) suspended from the correct lifting attachment by 4 leg chains. The load was being carried with the boom elevated at 56 degrees with 1.54m of extension with the truck driving slowly in first gear, when the truck turned a shallow corner on uneven ground it overturned coming to rest on a muck pile.

The load was being carried too high and was outside its safe working limits, the pendulum effect of the rebar caused the truck to over balance and fall to the side. No one was injured and the driver only suffered a minor bump to the head.

- Be aware of the different Safe Working Loads (SWL) for static & suspended loads
 - Site supervisors & managers, familiarise yourself with the duty charts of the lifting equipment on your site so you can see how quickly the SWL changes from 3500kg's to 125kg's with suspended loads. There are no built-in safety features to prevent this happening.
