SAFETY NOTICE

Incident Involving Rear Gate Arm on 180 Coil Trailer

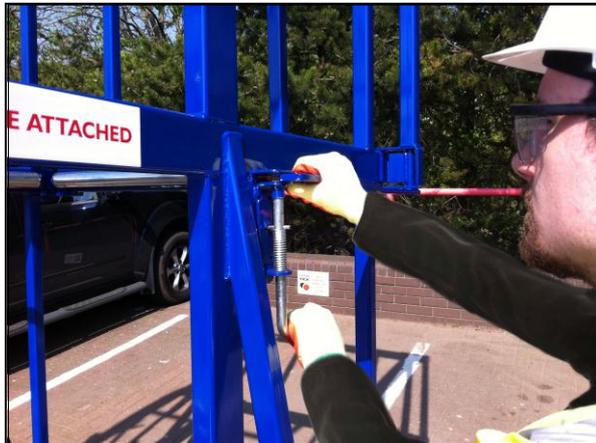
Retraction of shoot bolt
free hand supporting the arm

- Ensure that any pipe that is pressing against the inside of the rear gate is moved in order to relieve pressure on the gate before attempting to open it.
- Grip the rear gate arm with your right hand and the shoot bolt/securing pin with your left. Your right hand will ensure that the arm is restrained before the shoot bolt is released.
- Pull down the shoot bolt to release the rear gate arm, ensure that your right hand is still restraining the arm at this point.
- The arm is now free to pivot. Swing the arm out to the side, making the gate able to open. Ensure that you grip the arm with both hands whilst performing this step.

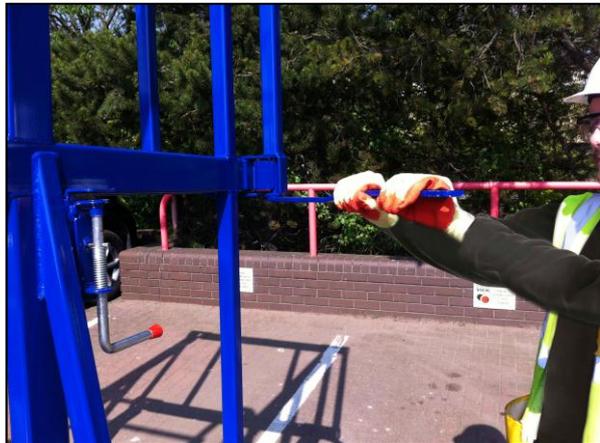
Removing arm from catch
supporting with both hands
