NLTI as result of fallen fencing

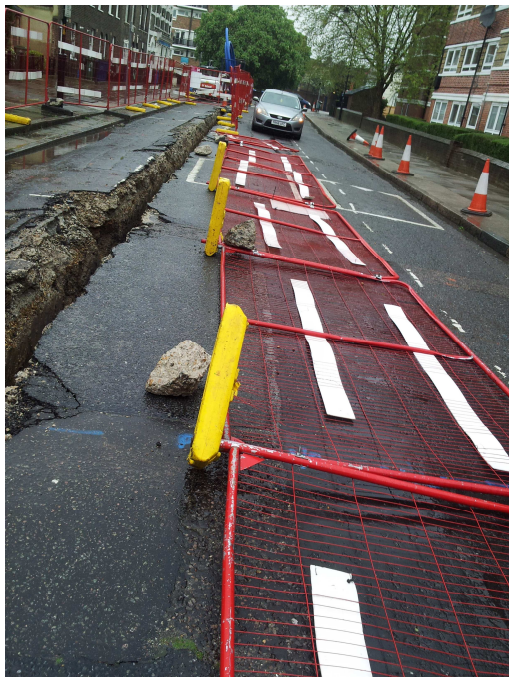
An MGJV supervisor was contacted out of hours on a weekend as a result of HERAS fence panels being blown over in the wind and obstructing traffic. The supervisor tried to ring the contractor responsible for these works but could not get in touch with anyone. The supervisor attended site and parked his car so as to halt the flow of traffic. As he attempted to lift the HERAS fence panels they came back down on him trapping him under the panels. The supervisor managed to free himself from the panels and drag the panels out of the road.

Protocols should be set up to ensure that contractors are responsible for maintaining their sites and ensuring that a two man team is available for out of hour's assistance.

Cross bracing as a minimum with an adequate supply of sandbags should have been used instead of sporadic "lumps of concrete"

Persons should not attempt to manually handle loads that they can not physically move. In this case as a final option the correct tools should have been available to dismantle the HERAS fence panels using the correct spanner for the brackets
