HEALTH AND SAFETY ALERT N^o 6

EXPOSURE TO ALCALINE MATERIALS

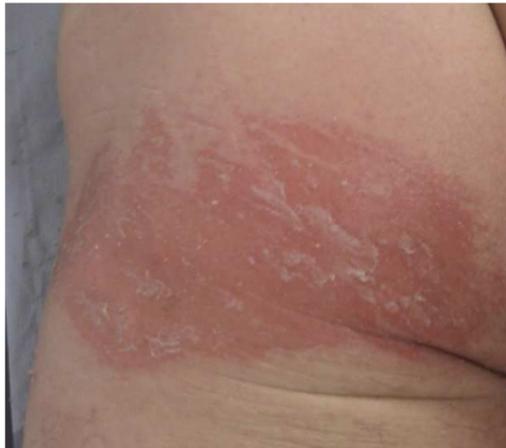
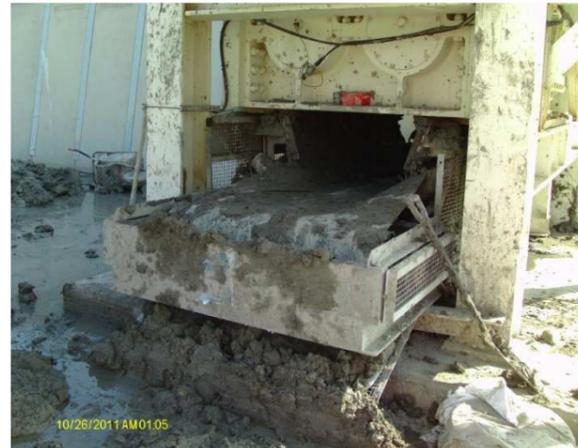
An incident occurred when the spoil from excavation of the Diaphragm wall works on site was loaded onto the conveyor by a loading shovel which tips the spoil into the conveyor hopper and onto the conveyor belt. On this occasion the spoil was too sticky/heavy for the gradient of the conveyor system causing the spoil to slide back down the conveyor and blocking the boot end of the conveyor belt.

This resulted in the conveyor team isolating the system and then removing the guards to enable them to clear the blockage.

The IP involved in this operation suffered a reaction to his skin on his left buttock as he sat in the spoil which he was attempting to clear. An alkaline substance within the spoil soaked through his overalls onto his skin.

- Improve control of addition of chemicals into the spoil
- Ensure anyone involved in spoil handling/removal process is briefed on any associated risks.
- Ensure Risk Assessment/Method Statement covers maintenance and breakdown issues.
- Eliminate the risk of exposure to all regarding levels of pH and ensure the correct PPE and control measures are in place.
